STRUCTURAL CONDITION EVALUATION OF

7 SERPENTINE STREET

COPPER CLIFF, ONTARIO

MAY 5, 2016

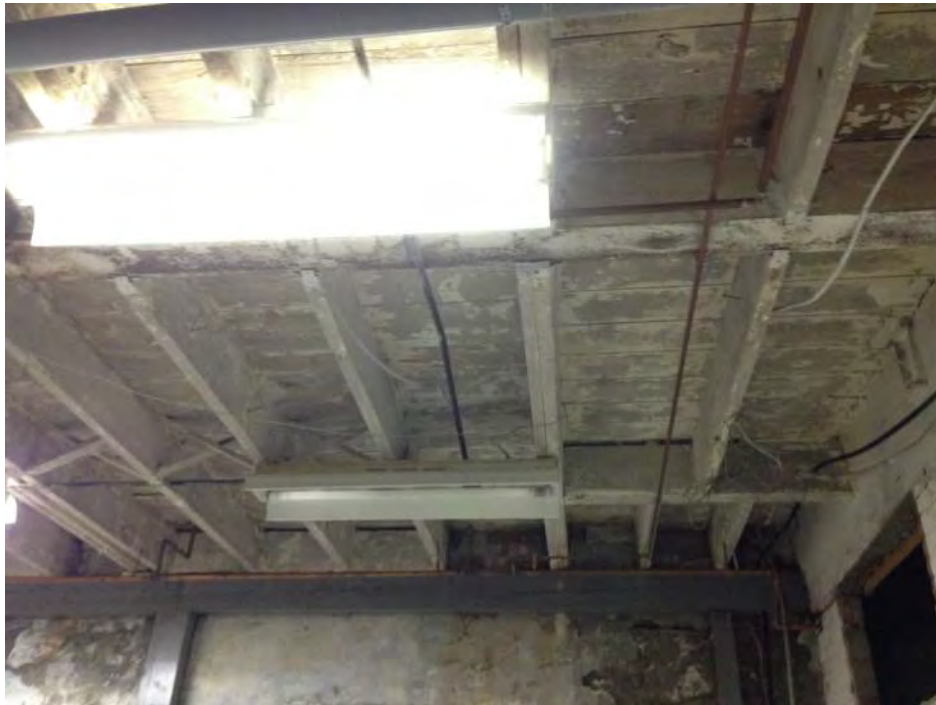
The original wood decking is supported by 2x10 wood joists spaced at 24" centres on the west half of the building and 14" centres on the east half. The joists span between load-bearing masonry walls, steel beams and exterior foundation walls. In general, the joists show evidence of water damage and paint delamination. A small area in the east corridor of the basement also has evidence of previous fire damage. Metal joist hangers are missing or deteriorated at several locations and joist ends that are embedded in the exterior foundation walls are particularly moisture-damaged. Timber posts and beams have been added along the north wall in the west half of the building as joist end shoring; however, the shoring is also beginning to deteriorate due to the ongoing leakage.

Figure 8: Original wood floor framing below concrete slab.

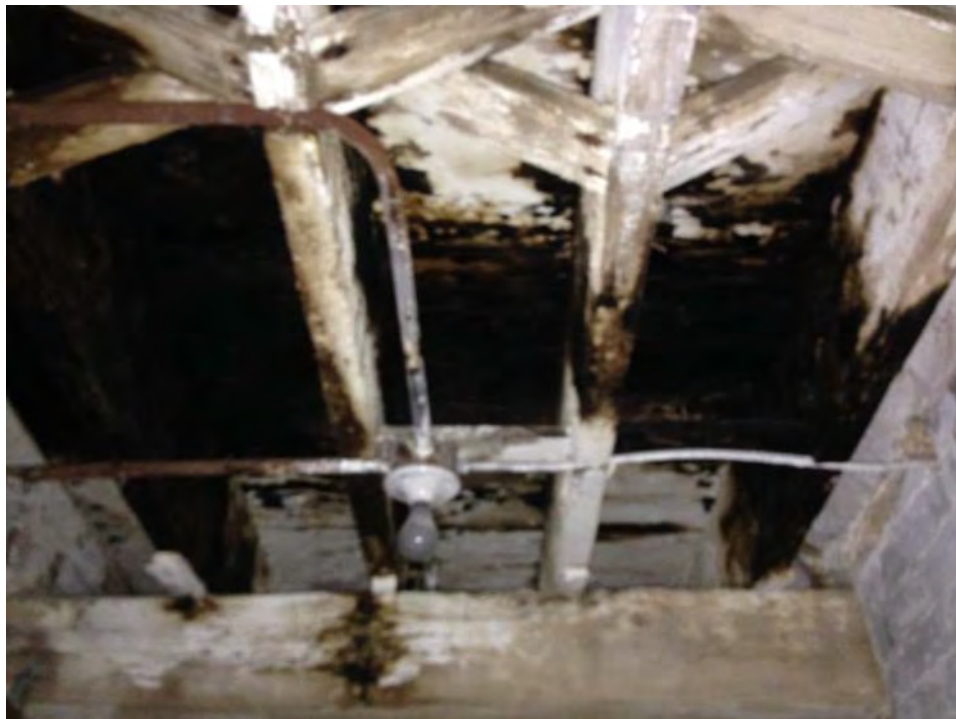
Figure 10: Fire damage to wood joists in basement corridor.

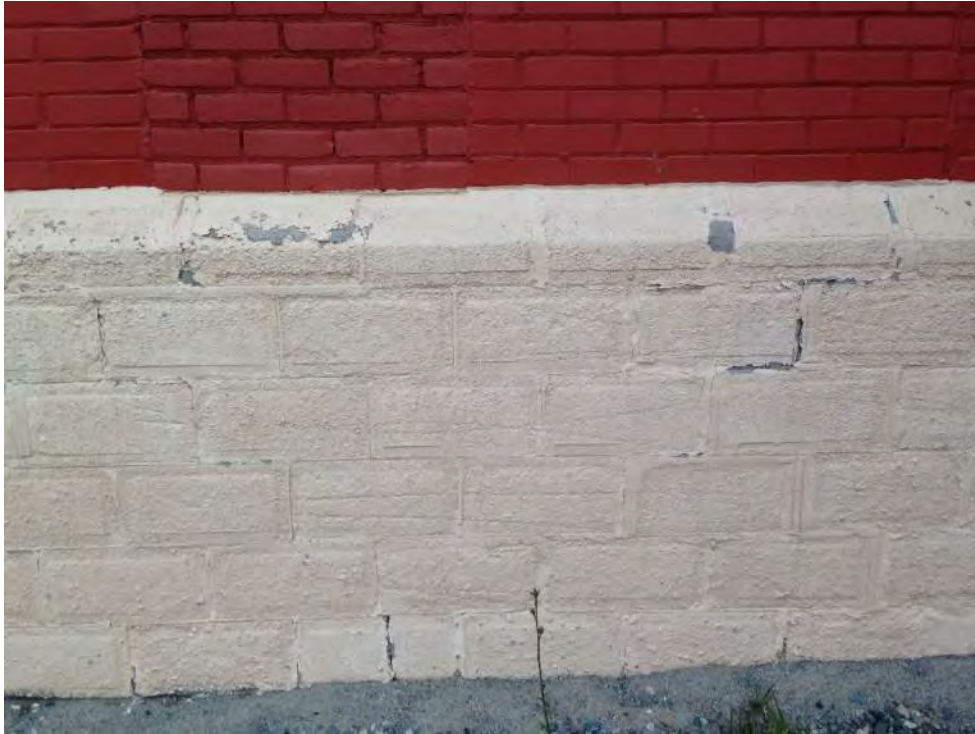
Above grade, the concrete block mortar joints are cracked and also allowing water ingress at numerous locations but are more predominant at the northeast corner, where a planter box is built tight to the foundation with no evidence of a waterproofing membrane. There is also a gutter downspout terminating close to the foundation wall in this location. Basement window perimeters are poorly waterproofed with large gaps allowing significant water penetration and exacerbating the deterioration of the surrounding concrete.

Figure 13: Typical concrete block foundation wall cracking above grade.

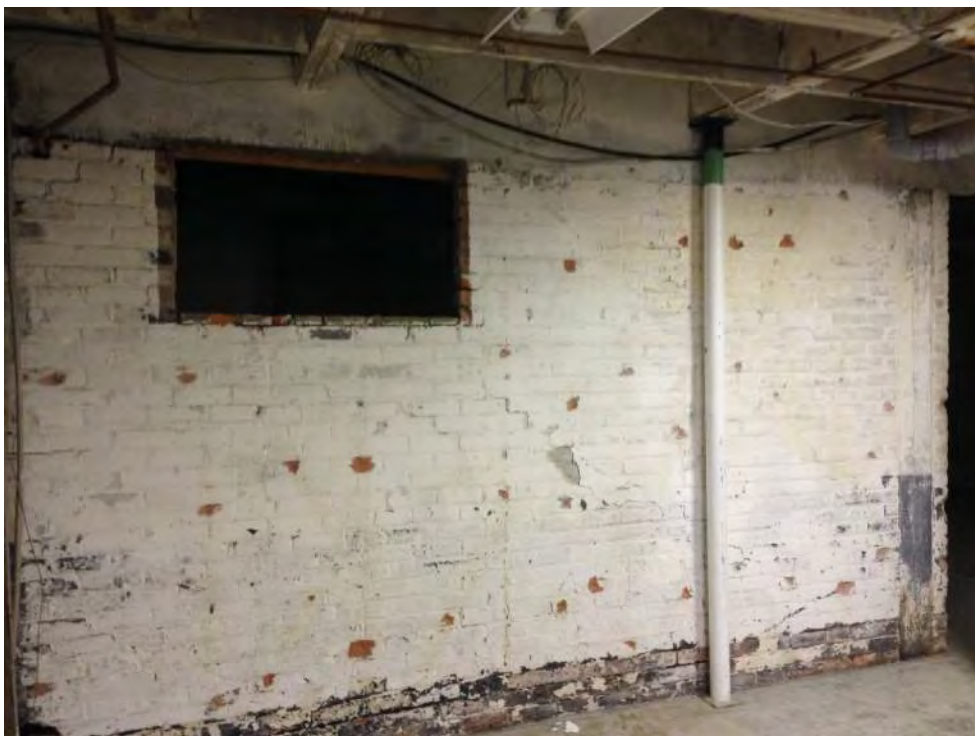
Interior load-bearing brick walls provided in the basement support the main floor slab and floor framing. The brick walls are generally very brittle and in poor condition. Brick walls were not reinforced to accommodate the concrete slab addition and are too slender for 4" masonry construction. Temporary timber or steel posts have been installed in three locations to support deteriorated brick at steel beam bearing conditions. Original brick walls will require reconstruction in several locations throughout the basement. New foundations may be required below walls if the slab-on-grade was not thickened to accommodate the line loading. This condition needs to be exposed and confirmed during the repair project.

Figure 14: Typical deteriorated condition of load-bearing brick walls in basement.
