'AMENDED' - SELLING INFORMATION -
(THIS IS NOT A TENDER)

- Municipal Address: **7 Serpentine Street, Copper Cliff, ON**
On which is situate the building commonly referred to as the former Copper Cliff Fire Hall
- Legal Description: PIN 73599-0173(LT), Surface Rights Only, formerly Parcel 40945, SES, Lot 79, Plan M-1025, Township of McKim, City of Greater Sudbury
- Approximate Size of Site: 602 square meters (6,480 square feet)
- Official Plan & Zoning: The lands are designated “Mixed Use Commercial” in the Official Plan and are zoned “C2”- General Commercial, in Zoning By-law 2010-100Z.

STRUCTURAL CONDITION EVALUATION OF

MAY 5, 2016

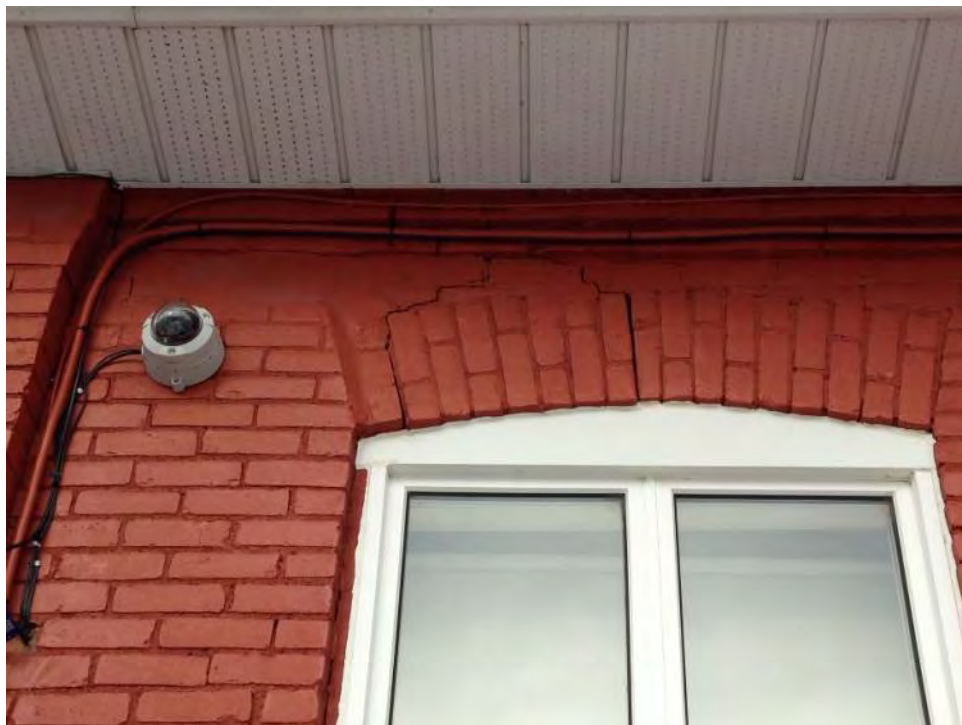
The perimeter walls above grade are believed to consist of load-bearing, double-wythe masonry walls. Walls are exposed on the exterior and finished with metal lath and cement parging on the interior. Several original openings have been infilled and new openings made since original construction. The exterior brick is generally in fair, but weathered condition. There are several cracked bricks and mortar joints, particularly at the original arched window head lintels where loose brick is being held up the window frame and is at risk of falling. The loose portions of masonry at the arches need to be repaired immediately as they pose a potential safety risk to people on the exterior of the building. Removal of the brick is not an option since it would compromise the integrity of the lintel. There is a significant vertical crack on the south elevation, extending the full height of the wall. The crack appears to coincide with different vintages of brick, indicating movement has occurred between the brick infill and original brick.

Figure 4: Typical brick masonry cracking at original arched window lintels.

| No. | Description | Opinion of Cost |
|--|--|---|
| a) | Localized exterior brick masonry replacement and crack re-pointing/stitching | \$ 3,000 |

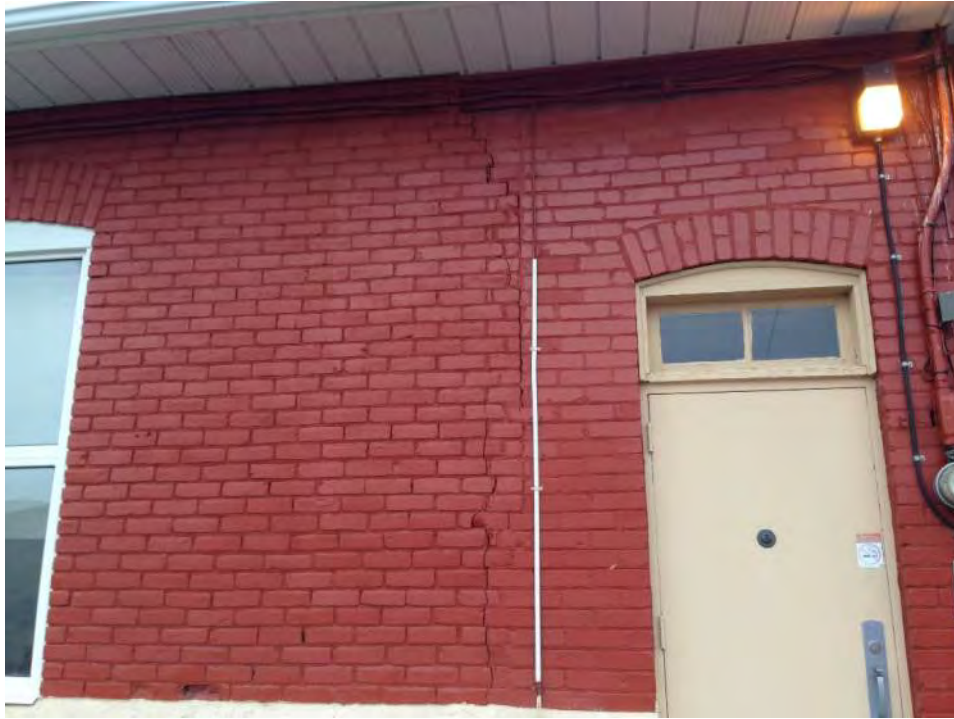
Figure 5: Vertical crack at south elevation. Original brick on left side of crack; infill brick to the right.

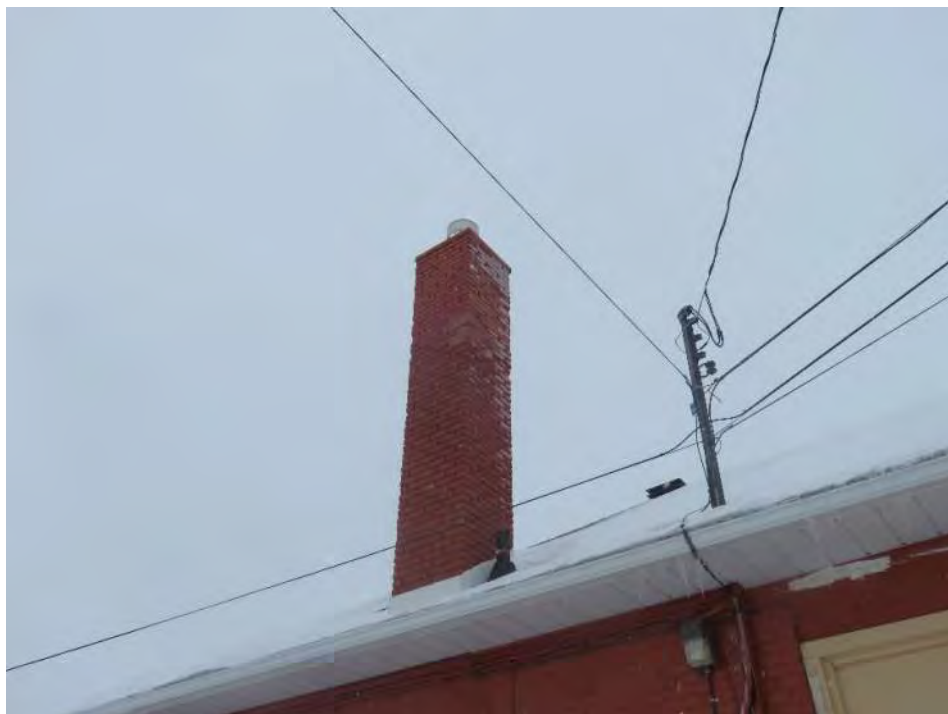
A brick masonry chimney extends approximately 10' above the roof at the southeast corner of the roof. The chimney brick is in poor condition with evidence of spalling and previous brick replacement. Up-close review and removal of loose brick is required immediately as they pose a potential safety risk to people on the exterior of the building.

Figure 6: Brick chimney at southwest corner of roof.

| No. | Description | Opinion of Cost |
|--|--|---|
| 1.2 | Up-close review and removal of loose chimney brick | \$ 600 |

| No. | Description | Opinion of Cost |
|--|--|---|
| b) | ***Optional*** Chimney replacement or removal and partial re-roofing | \$ 3,000 |

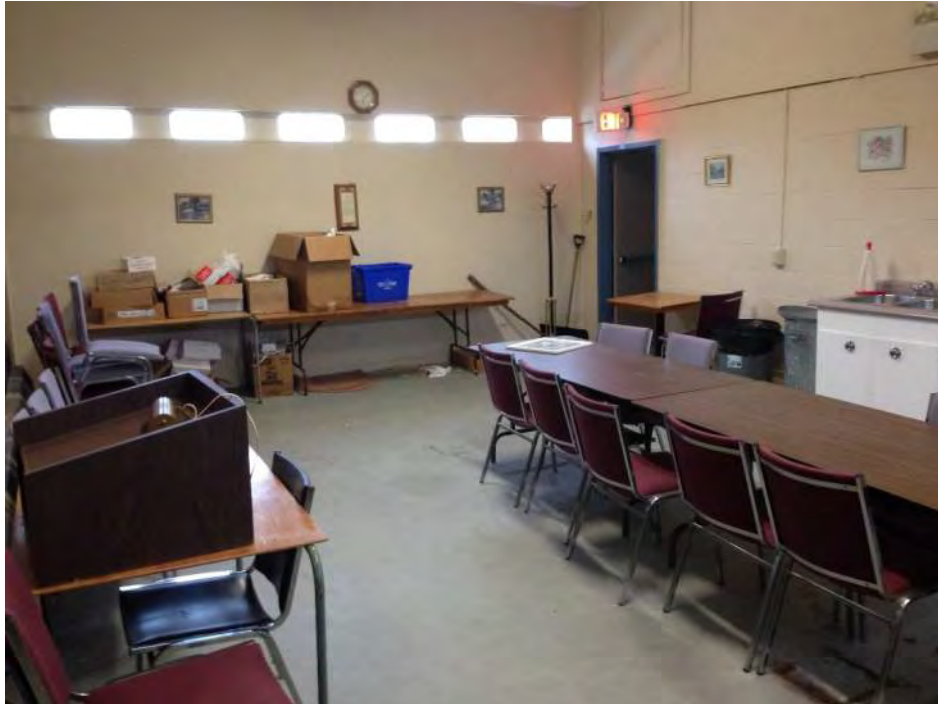
According to the concrete imaging report by Sutton Inspection Services Inc., dated April 24, 2016, the main floor slab consists of 6" concrete reinforced with one layer of small diameter rebar or wire mesh near the bottom of the slab. The slab spans between load-bearing masonry walls and steel beams. The majority of the slab topside surface is exposed with minimal surface cracking where visible. Concrete creep was noticeable within the community hall but appeared to meet tolerance limits for concrete slabs.

Figure 7: Main floor concrete slab.

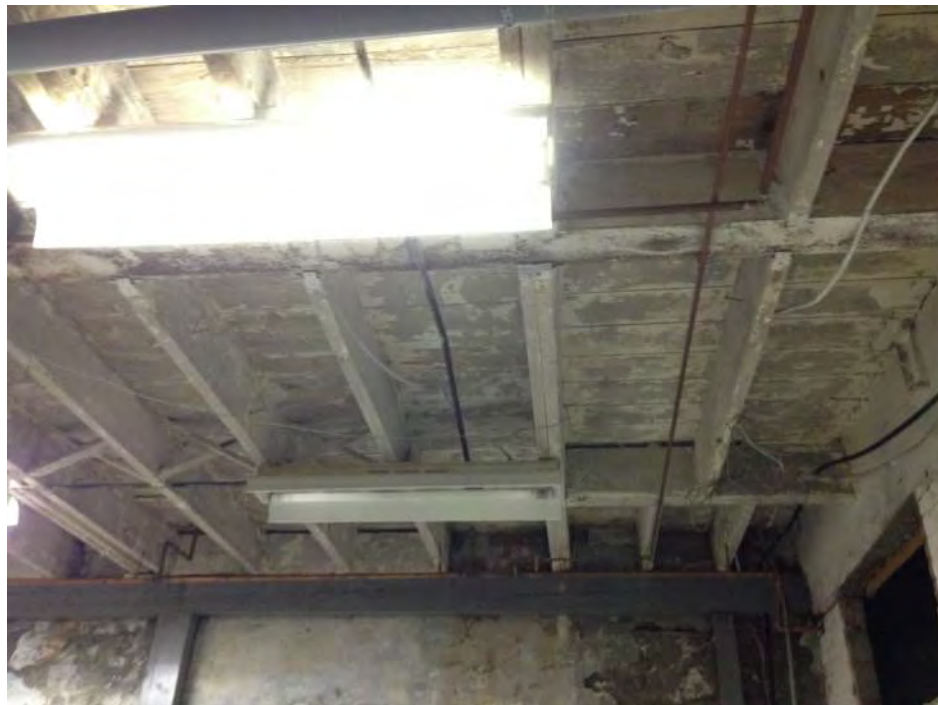
The original wood decking is supported by 2x10 wood joists spaced at 24" centres on the west half of the building and 14" centres on the east half. The joists span between load-bearing masonry walls, steel beams and exterior foundation walls. In general, the joists show evidence of water damage and paint delamination. A small area in the east corridor of the basement also has evidence of previous fire damage. Metal joist hangers are missing or deteriorated at several locations and joist ends that are embedded in the exterior foundation walls are particularly moisture-damaged. Timber posts and beams have been added along the north wall in the west half of the building as joist end shoring; however, the shoring is also beginning to deteriorate due to the ongoing leakage.

Figure 8: Original wood floor framing below concrete slab.

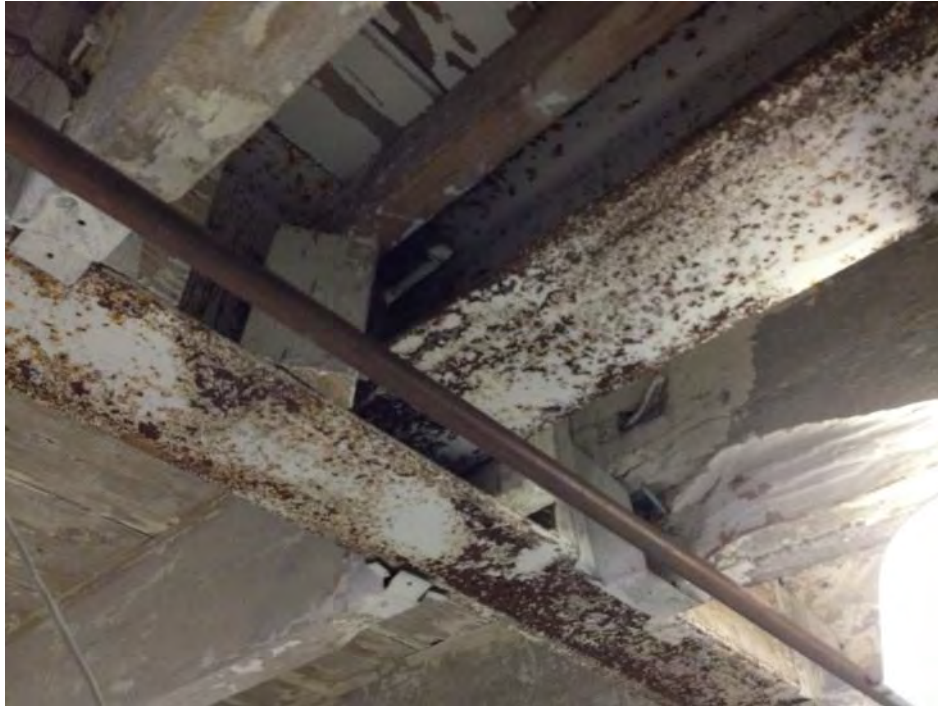
According to the steel inspection report by Laabs Industries, dated April 15, 2016, the original steel beams are early vintage structural steel with a yield strength of 30ksi (by comparison, current structural steel is at least 44ksi). A newer structural steel column and footing appears to have been added below the beam on the east side of the basement, possibly to address noticeable deflections following concrete slab placement. In general, all steel beams and bolted connections have surface corrosion, likely from the high humidity levels within the basement; however, no significant section loss was observed. Existing beams should be cleaned and coated for corrosion protection.

Figure 9: Typical steel beam surface corrosion.

| No. | Description | Opinion of Cost |
|--|--|---|
| b) | Clean and re-paint existing corroded steel beams | \$ 2,000 |

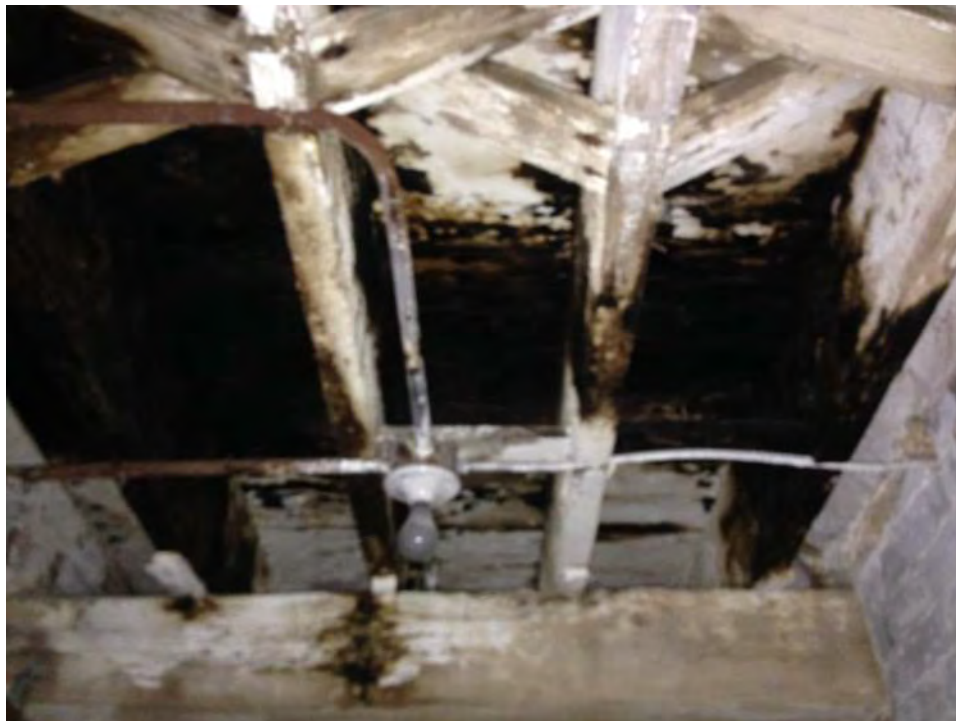
Figure 10: Fire damage to wood joists in basement corridor.

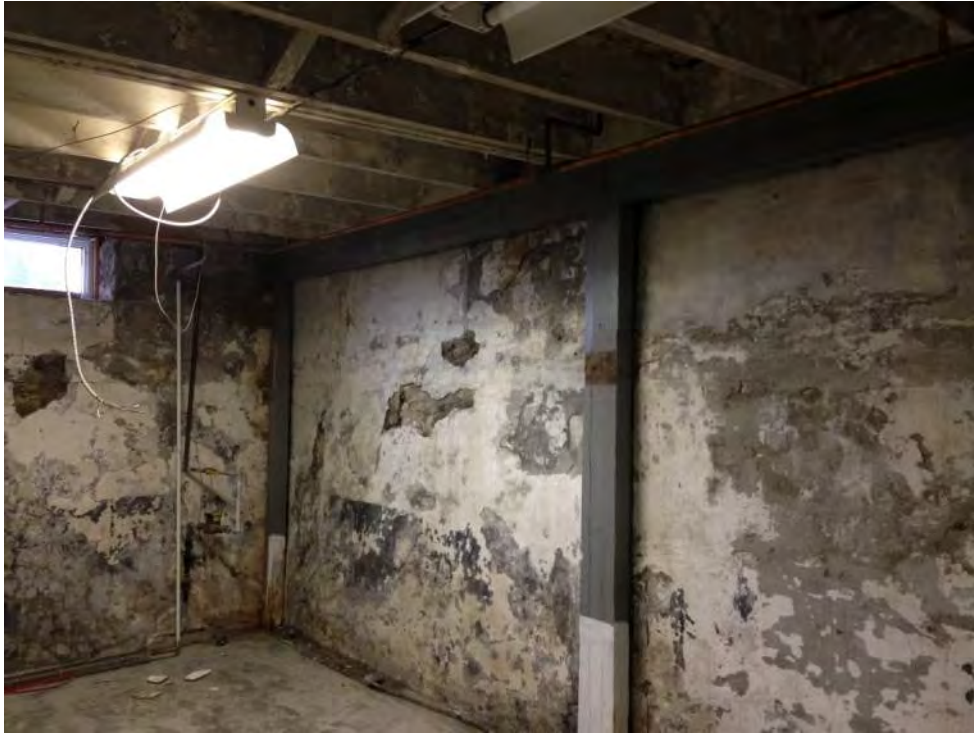
According to the concrete imaging report by Sutton Inspection Services Inc., dated April 24, 2016, the perimeter basement walls consist of unreinforced 6" cast-in-place concrete walls below grade with concrete block above grade. All basement walls are generally in a weathered condition with excessive cracking and spalling observed along the north wall and the north half of the east and west walls. Staining on the interior face of the basement walls at these locations indicate that the cracks have resulted in a significant amount of water infiltration. The main floor slab is providing minimal lateral restraint to the top of wall as the concrete stops below the floor structure, therefore the walls are acting as cantilevered retaining walls. The walls are visibly bowed inwards, likely due to lateral earth pressure, particularly on the north and east elevations, where grade is higher and moisture ingress is more prevalent. Additional concrete walls have been built tight to the southwest corner foundation, possibly to reinforce bowing walls in this location.

Figure 11: Concrete foundation walls cracking and spalling below grade.

The extent of deterioration and damage observed in the basement walls on the north half of the building is such that we expect that they will require replacement. Localized crack repairs are not feasible in our opinion, and will only result in future damage at other locations. Reinforced concrete walls are necessary to safely support the lateral earth pressures and the weight of the building above. This will require temporary shoring of the building structure, sheet piling of the excavation and replacement of hard and soft landscaping, including the north elevation sidewalk and ramp. The remaining portion of the foundation perimeter could likely be patch repaired and crack injected. The entire building perimeter foundation walls should be waterproofed and perimeter drainage improved as part of the repairs. While the foundation walls are exposed, exterior insulation could also be added to reduce building heat loss and provide concrete freeze-thaw protection.

| No. | Description | Opinion of Cost |
|--|--|---|
| b) | Temporary shoring and re-construction of north foundation walls | \$ 100,000 |

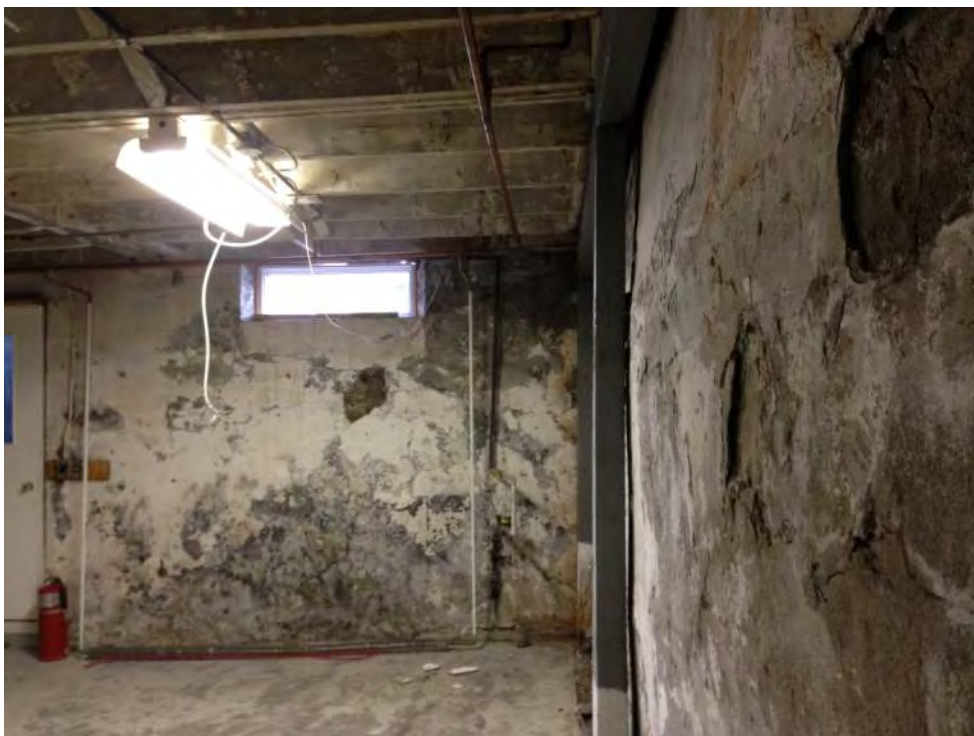
Figure 12: Concrete foundation walls are bowing inward.

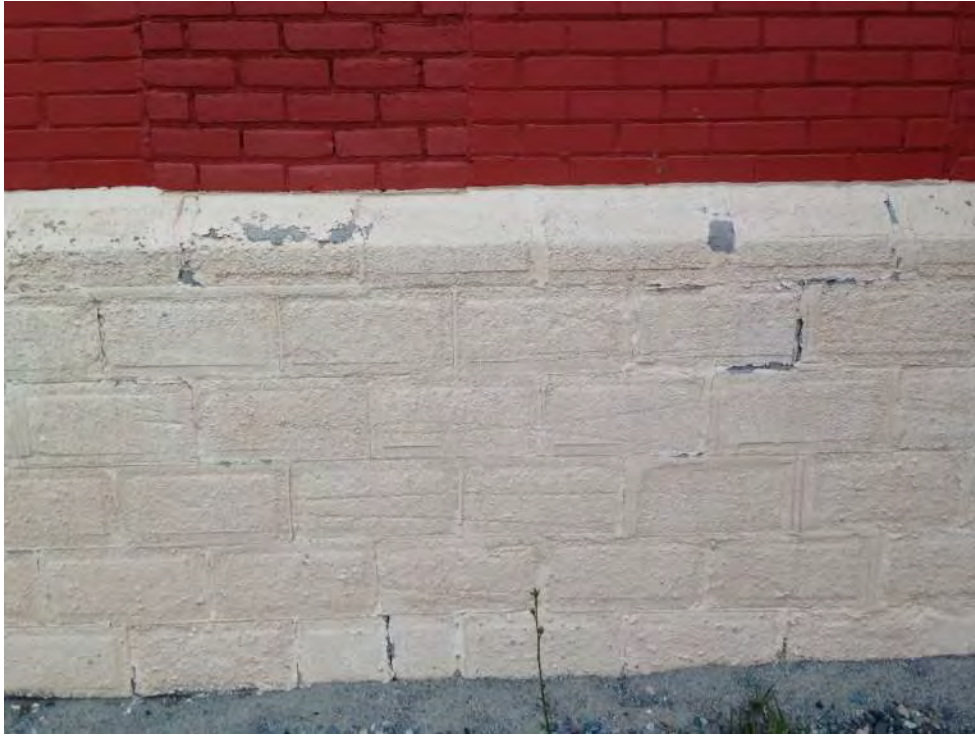
Above grade, the concrete block mortar joints are cracked and also allowing water ingress at numerous locations but are more predominant at the northeast corner, where a planter box is built tight to the foundation with no evidence of a waterproofing membrane. There is also a gutter downspout terminating close to the foundation wall in this location. Basement window perimeters are poorly waterproofed with large gaps allowing significant water penetration and exacerbating the deterioration of the surrounding concrete.

Figure 13: Typical concrete block foundation wall cracking above grade.

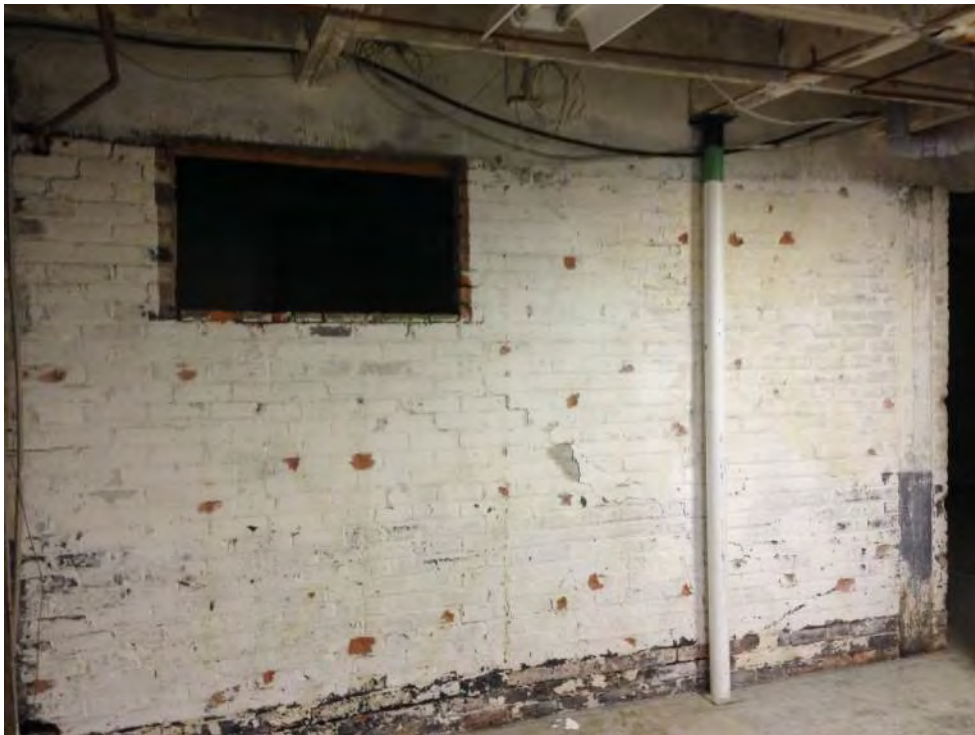
Interior load-bearing brick walls provided in the basement support the main floor slab and floor framing. The brick walls are generally very brittle and in poor condition. Brick walls were not reinforced to accommodate the concrete slab addition and are too slender for 4" masonry construction. Temporary timber or steel posts have been installed in three locations to support deteriorated brick at steel beam bearing conditions. Original brick walls will require reconstruction in several locations throughout the basement. New foundations may be required below walls if the slab-on-grade was not thickened to accommodate the line loading. This condition needs to be exposed and confirmed during the repair project.

Figure 14: Typical deteriorated condition of load-bearing brick walls in basement.

| No. | Description | Opinion of Cost |
|--|--|---|
| a) | Temporary shoring and repair/replacement of interior brick basement walls | \$ 25,000 |
