ORIGINAL REPORT
WOODLAND HERITAGE SERVICES LIMITED
STAGE ONE ARCHAEOLOGICAL ASSESSMENT

Prepared for

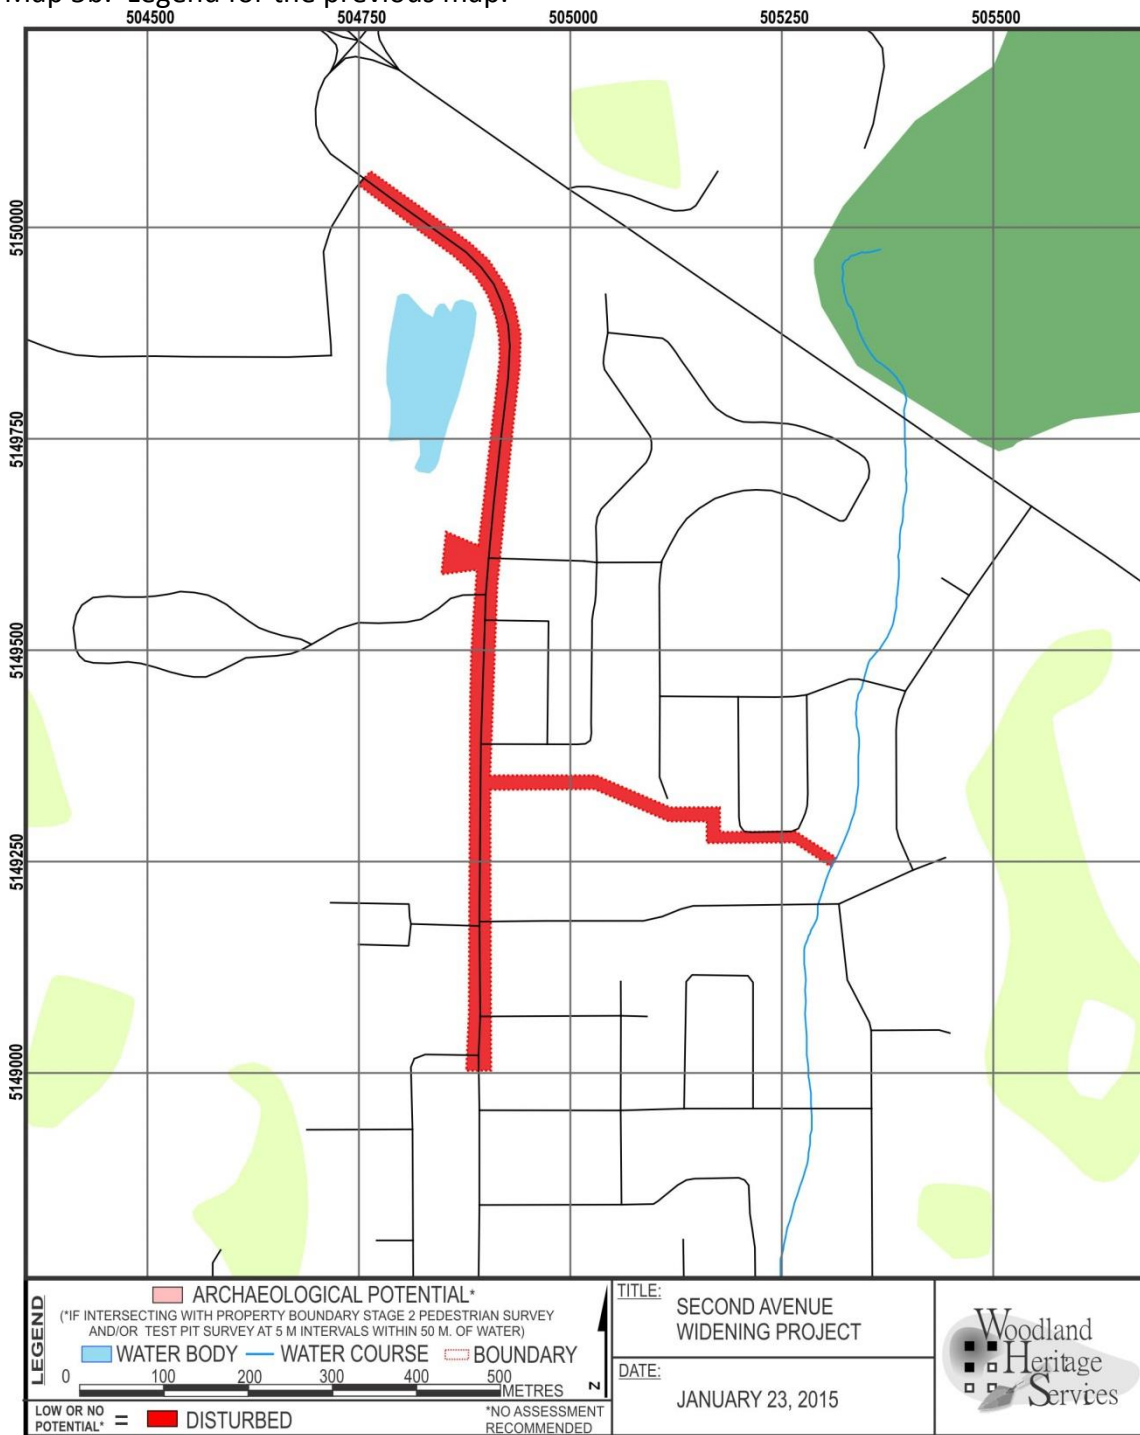
Map 6. Archaeological potential map showing the ground conditions affecting archaeological potential within the study area.

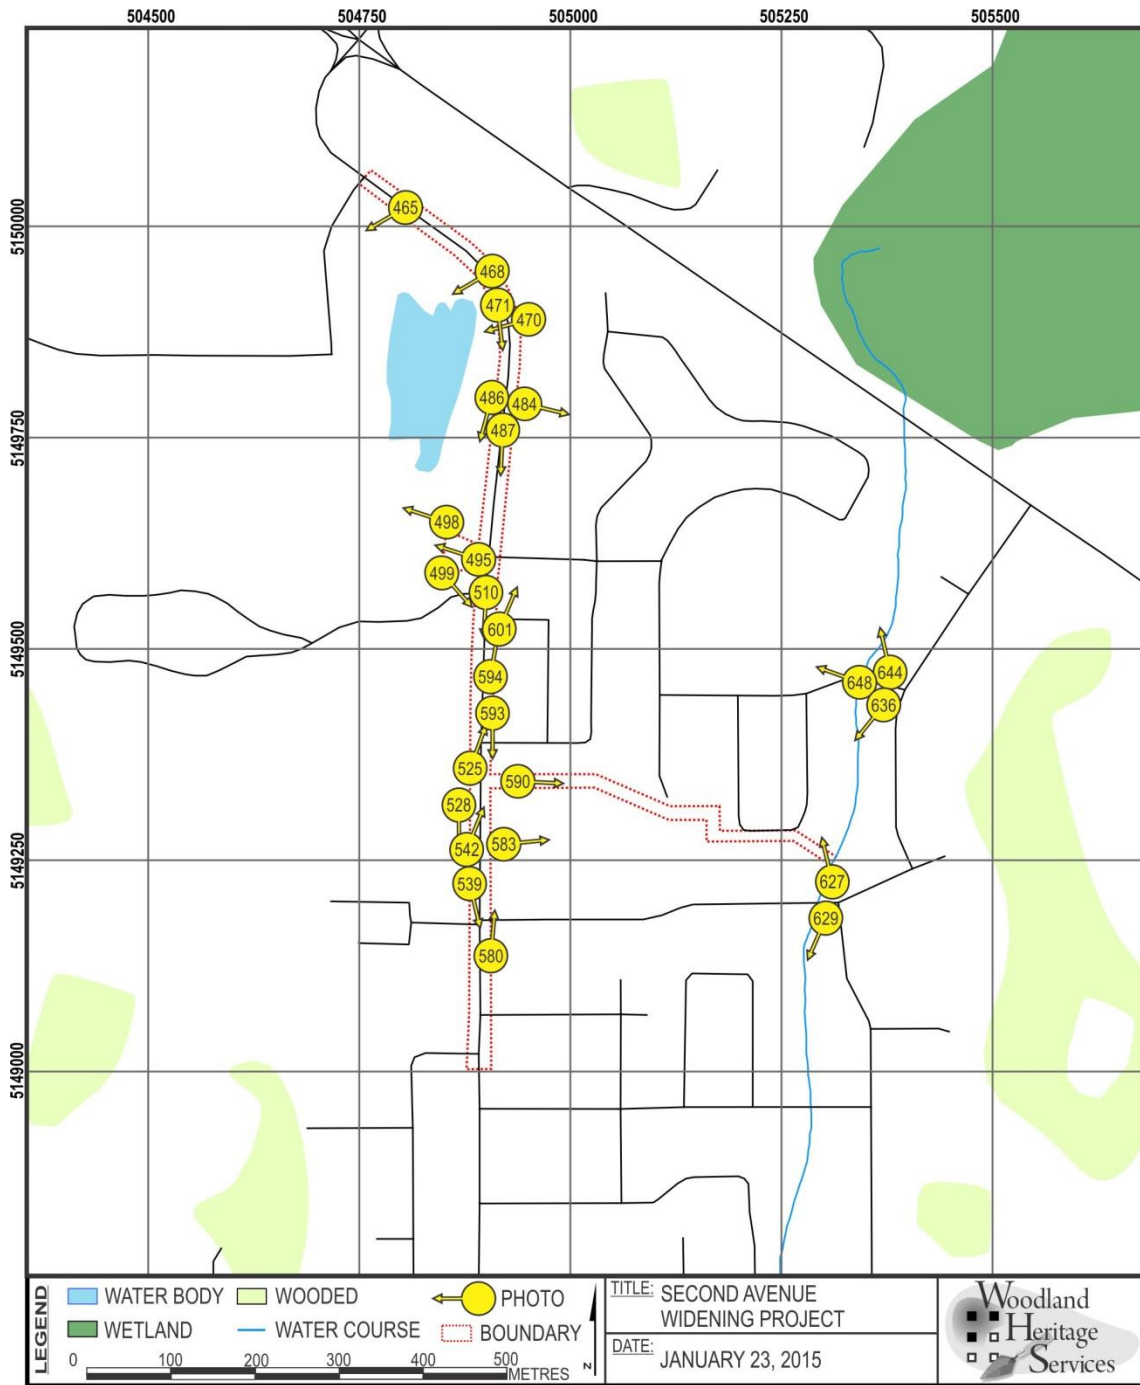
Map 7. Photograph location map showing the locations and directions of photographs used in this report.

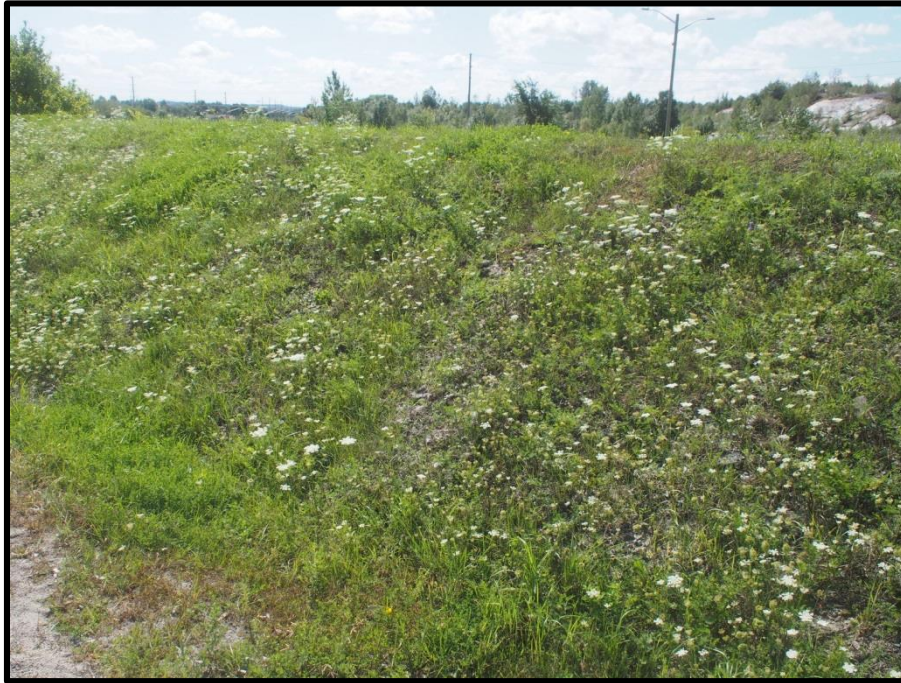
Image 3. Photograph 470 showing a raised mound on the west side of the road, a disturbance caused during the construction of the road.

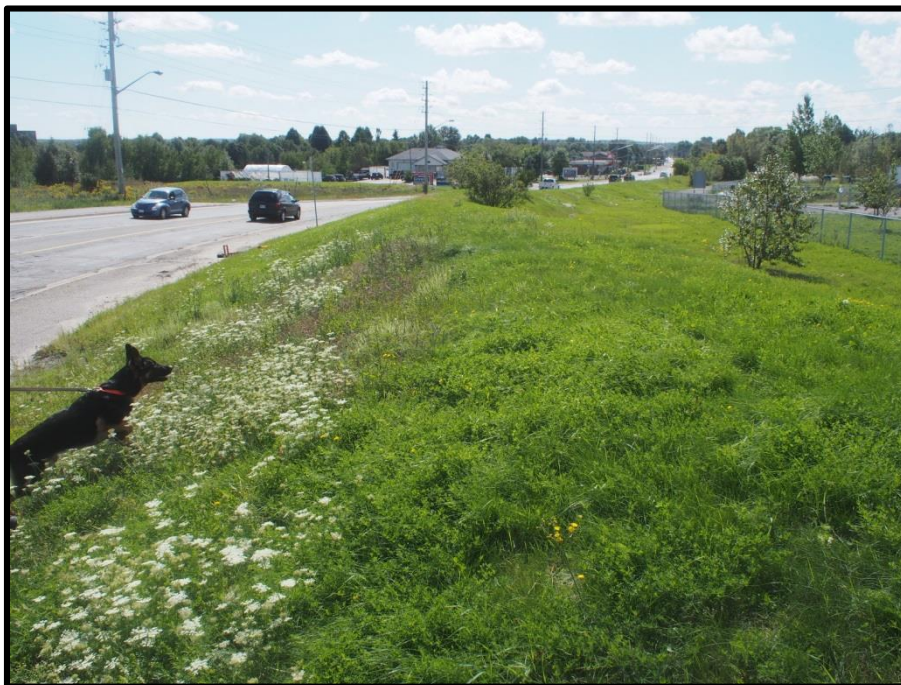
Image 4. Photograph 471 showing the drainage contouring on the west side of the road.
