# Ramsey Lake Subwatershed Study And Master Plan

## Public Information Centre #2

May 18,  
2017

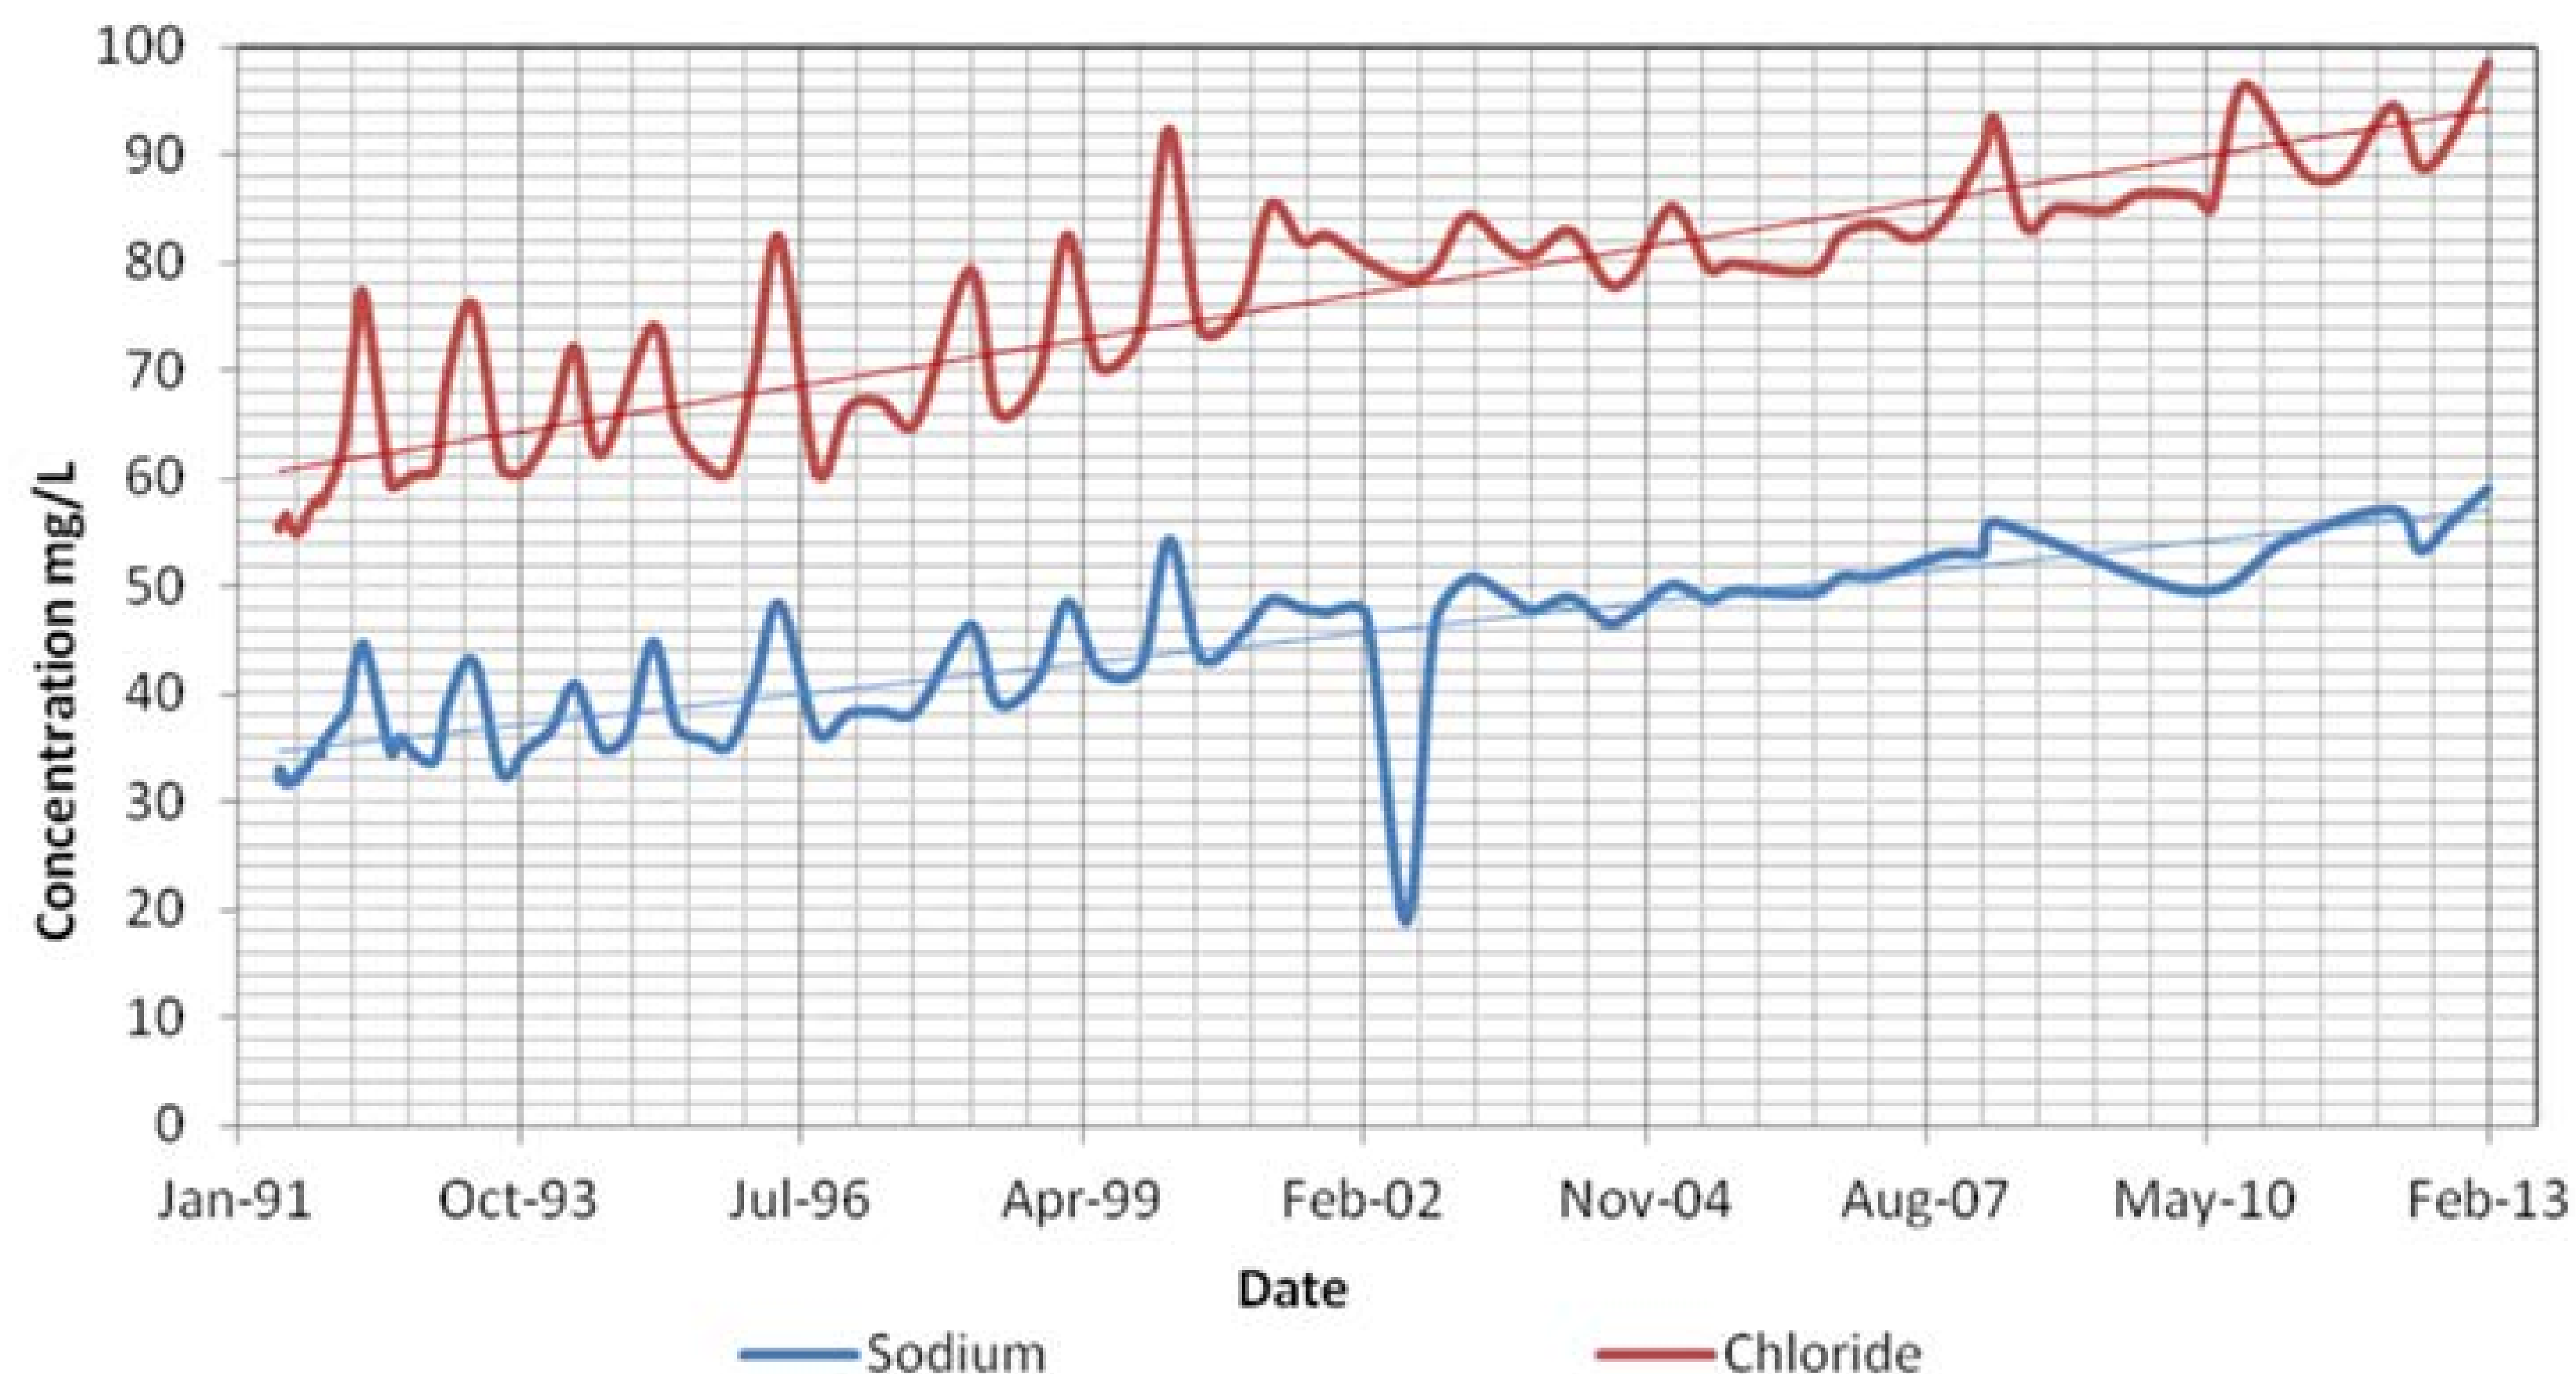
**Sodium and Chloride Concentrations in Ramsey Lake (1991-2013).**

- Sodium and chloride concentrations in Ramsey Lake have increased since 1991
  - Sodium concentrations have been  $> 50$  mg/L since 2013. The Ontario Drinking Water Standard for sodium is 200 mg/L
  - The water quality guideline for chloride, for the protection of aquatic life, is 120 mg/L

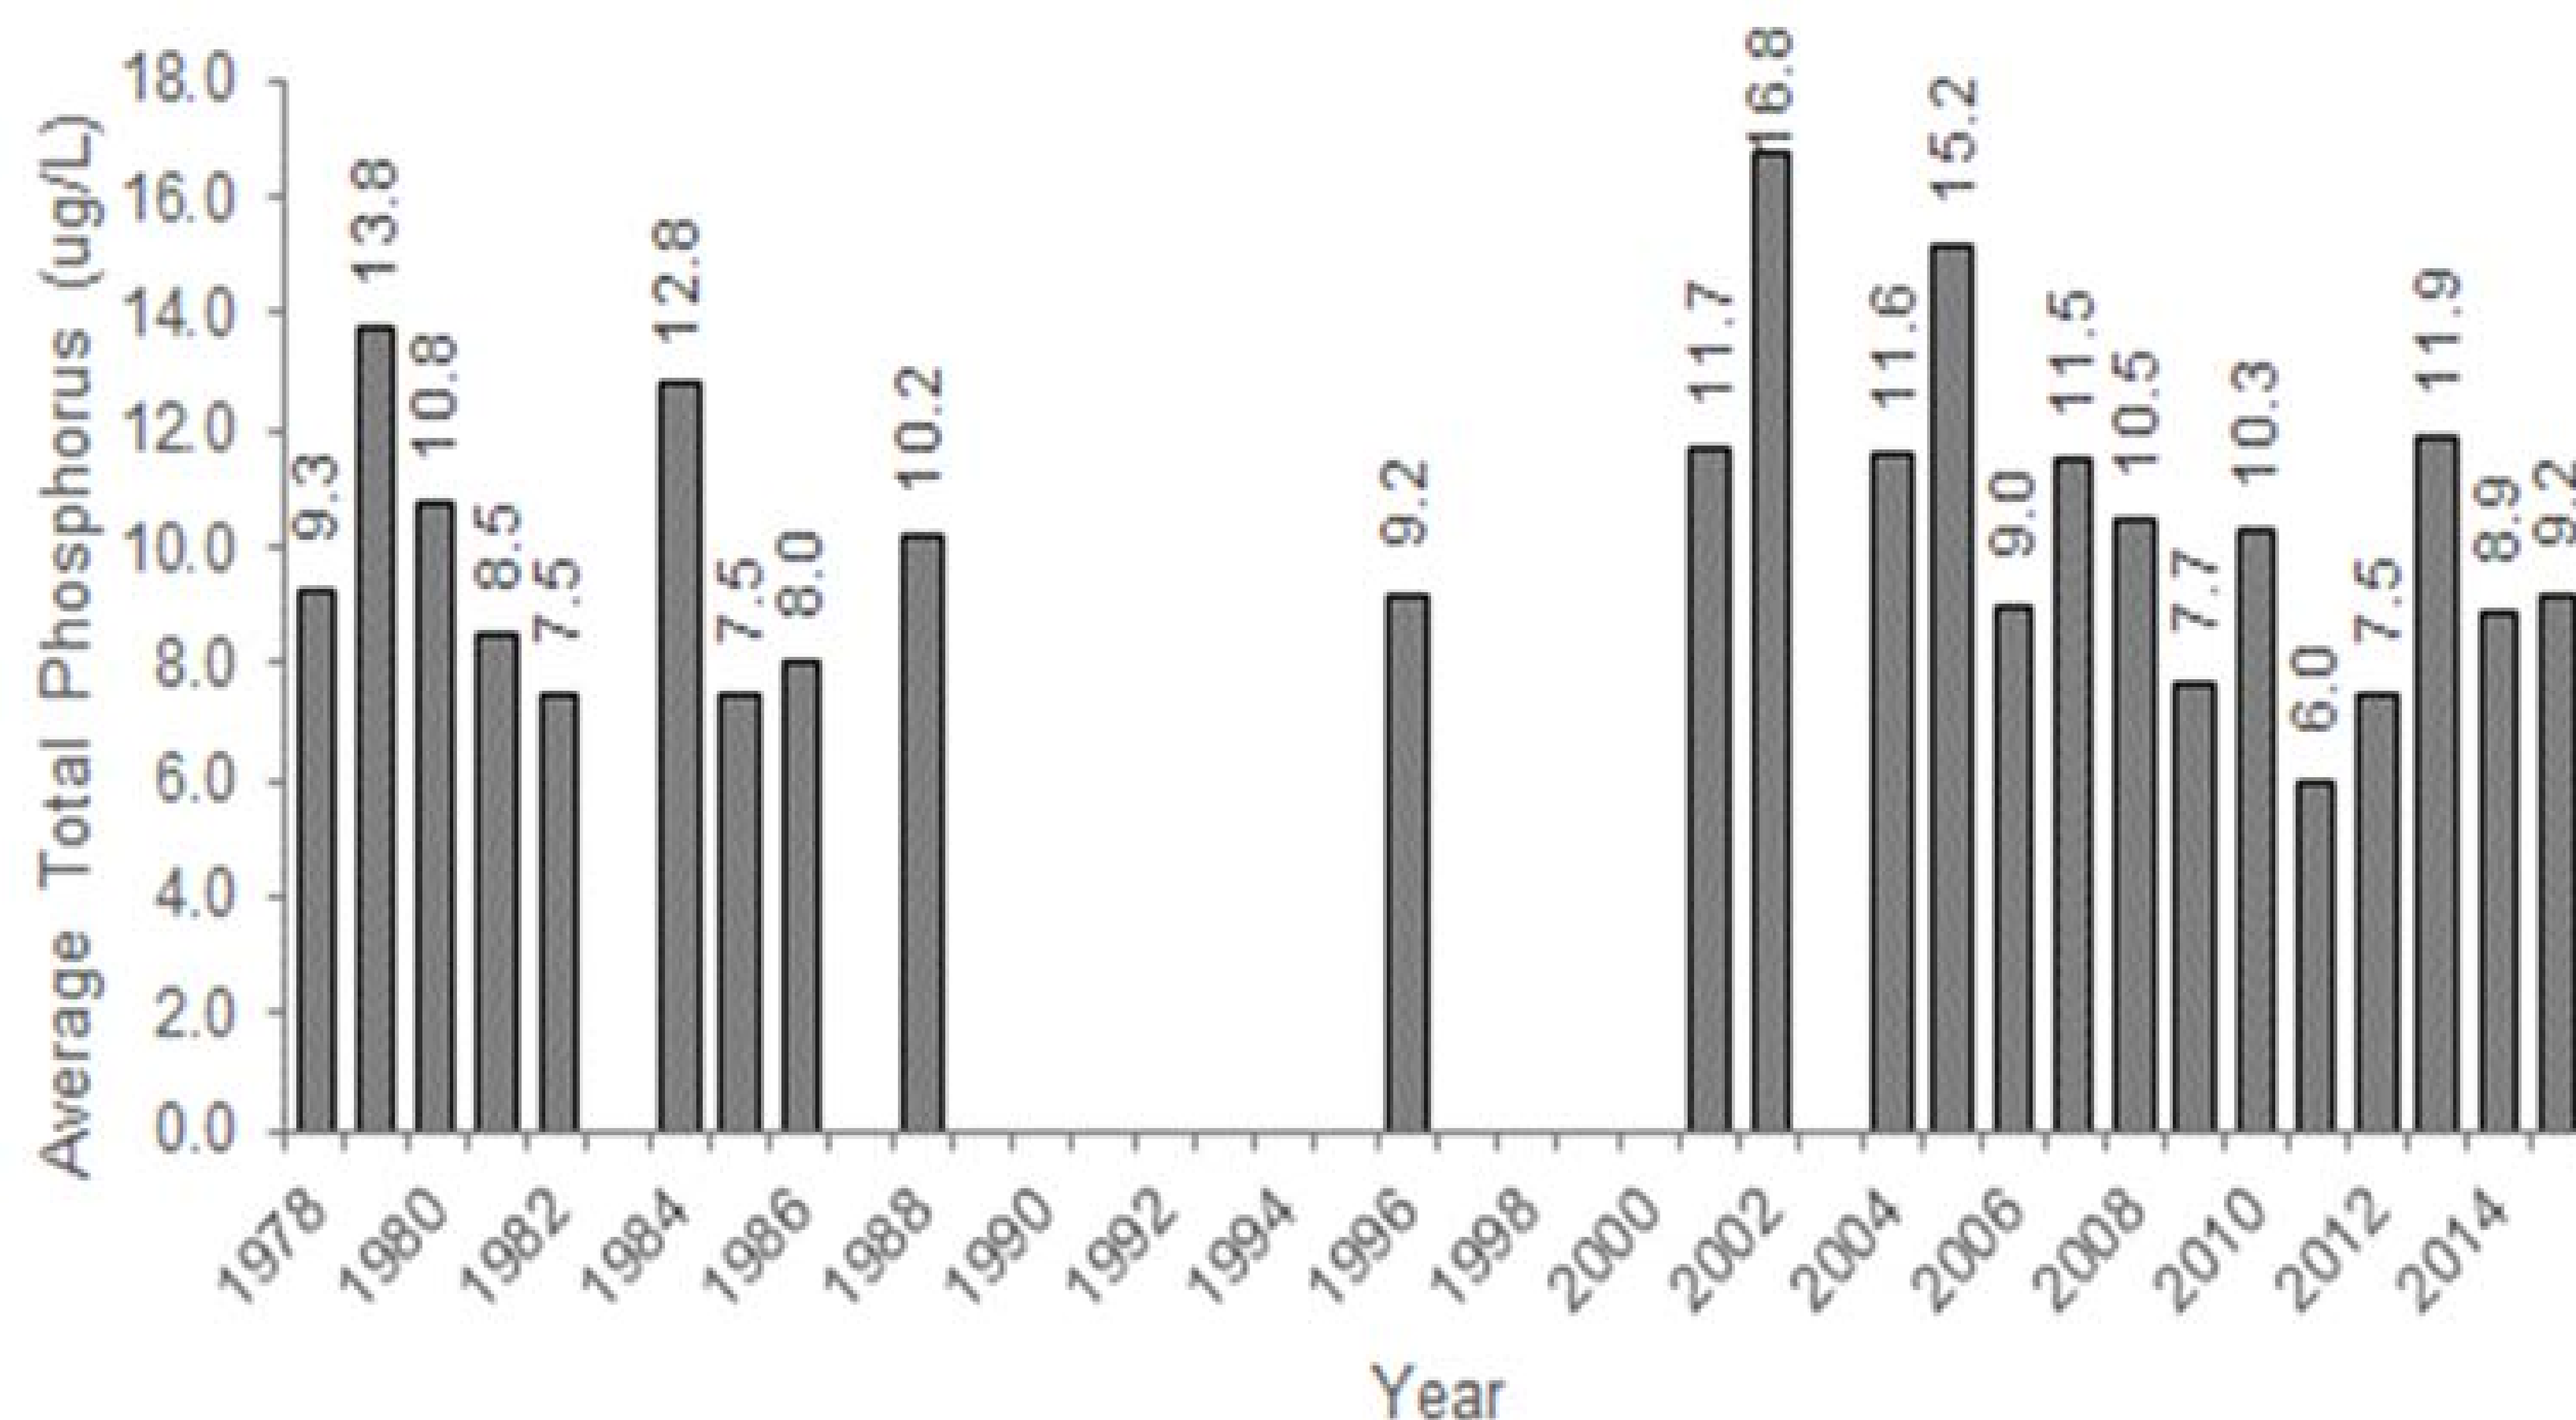
**Total Phosphorus Concentrations in Ramsey Lake (1978-2014).**

- Phosphorus concentrations have varied since the 1970's between about 10 and 17  $\mu\text{g/L}$ . The lake is currently classified as meso-eutrophic or moderately nutrient enriched
  - Runoff from urban land uses has resulted in an increase in phosphorus concentrations
  - Large weed beds throughout Ramsey Lake are one result of higher-than-natural phosphorus loads

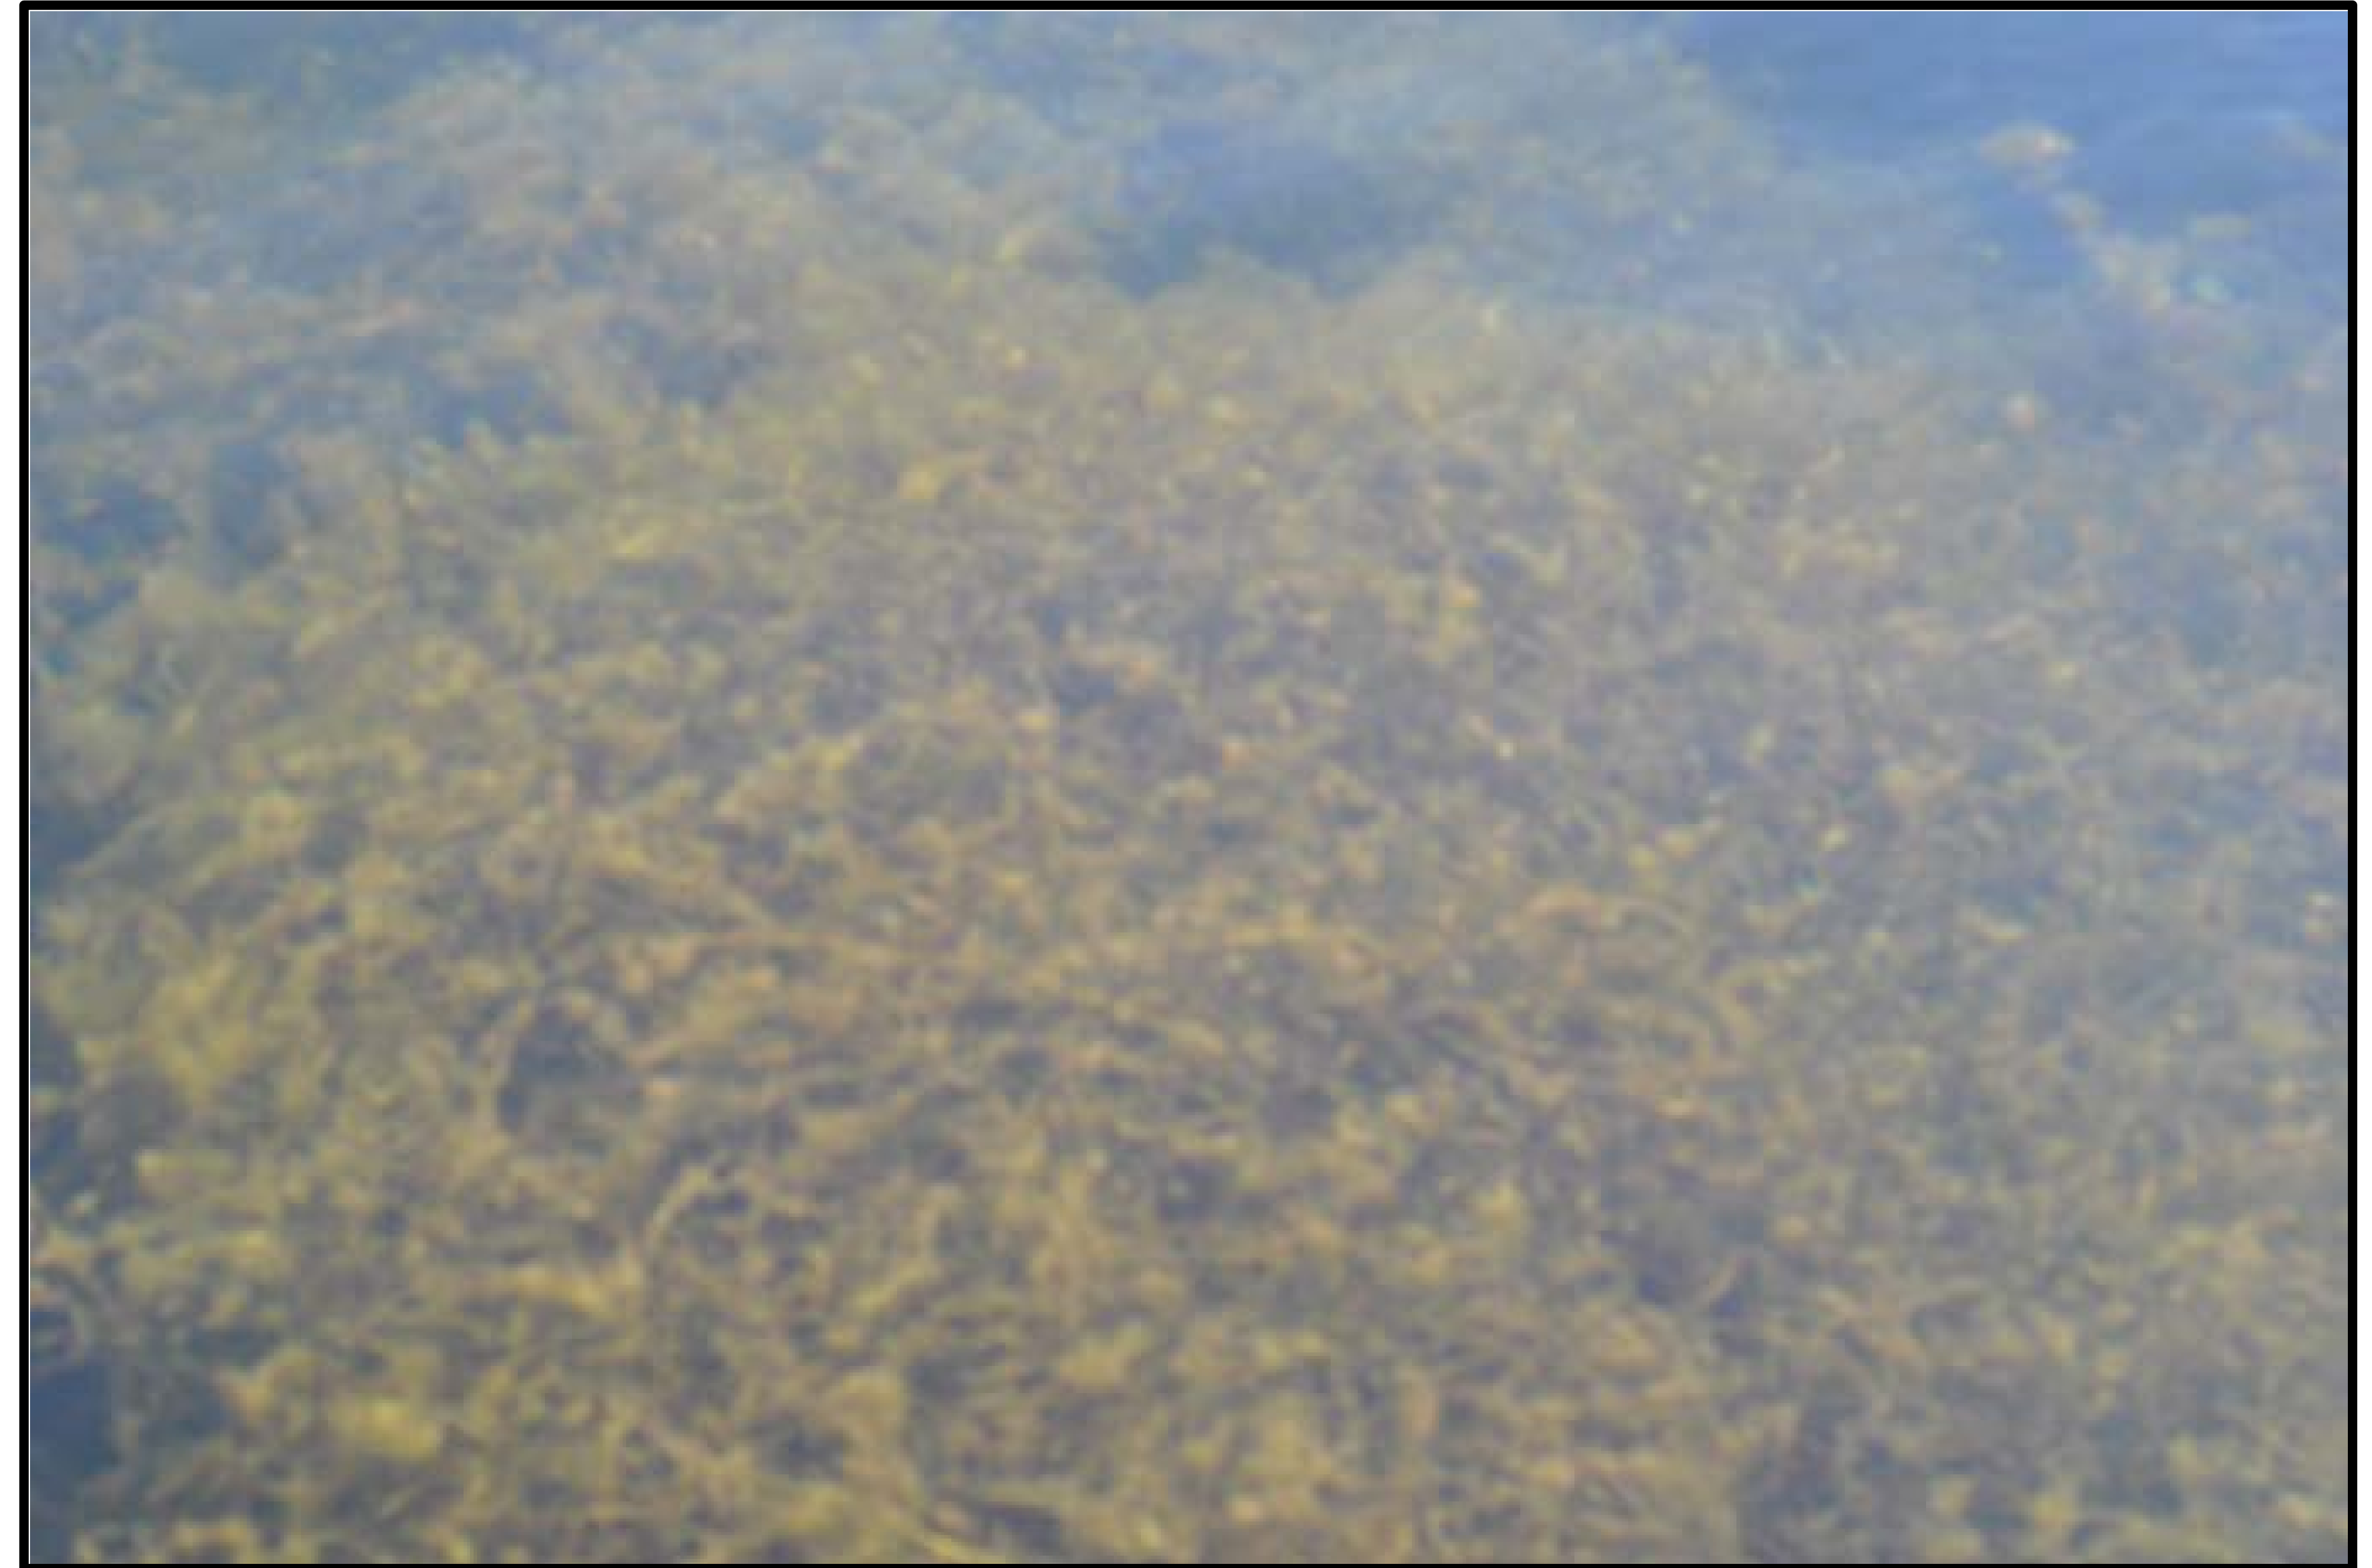
- **Blooms of cyanobacteria were reported from the lake in 2008, 2010, 2011 and 2012**
  - **Nuisance algal blooms are directly related to surface water runoff**
- **Eurasian water milfoil, an invasive aquatic plant is present in Ramsey Lake**

**Aquatic Plant Growth; Ramsey Lake**

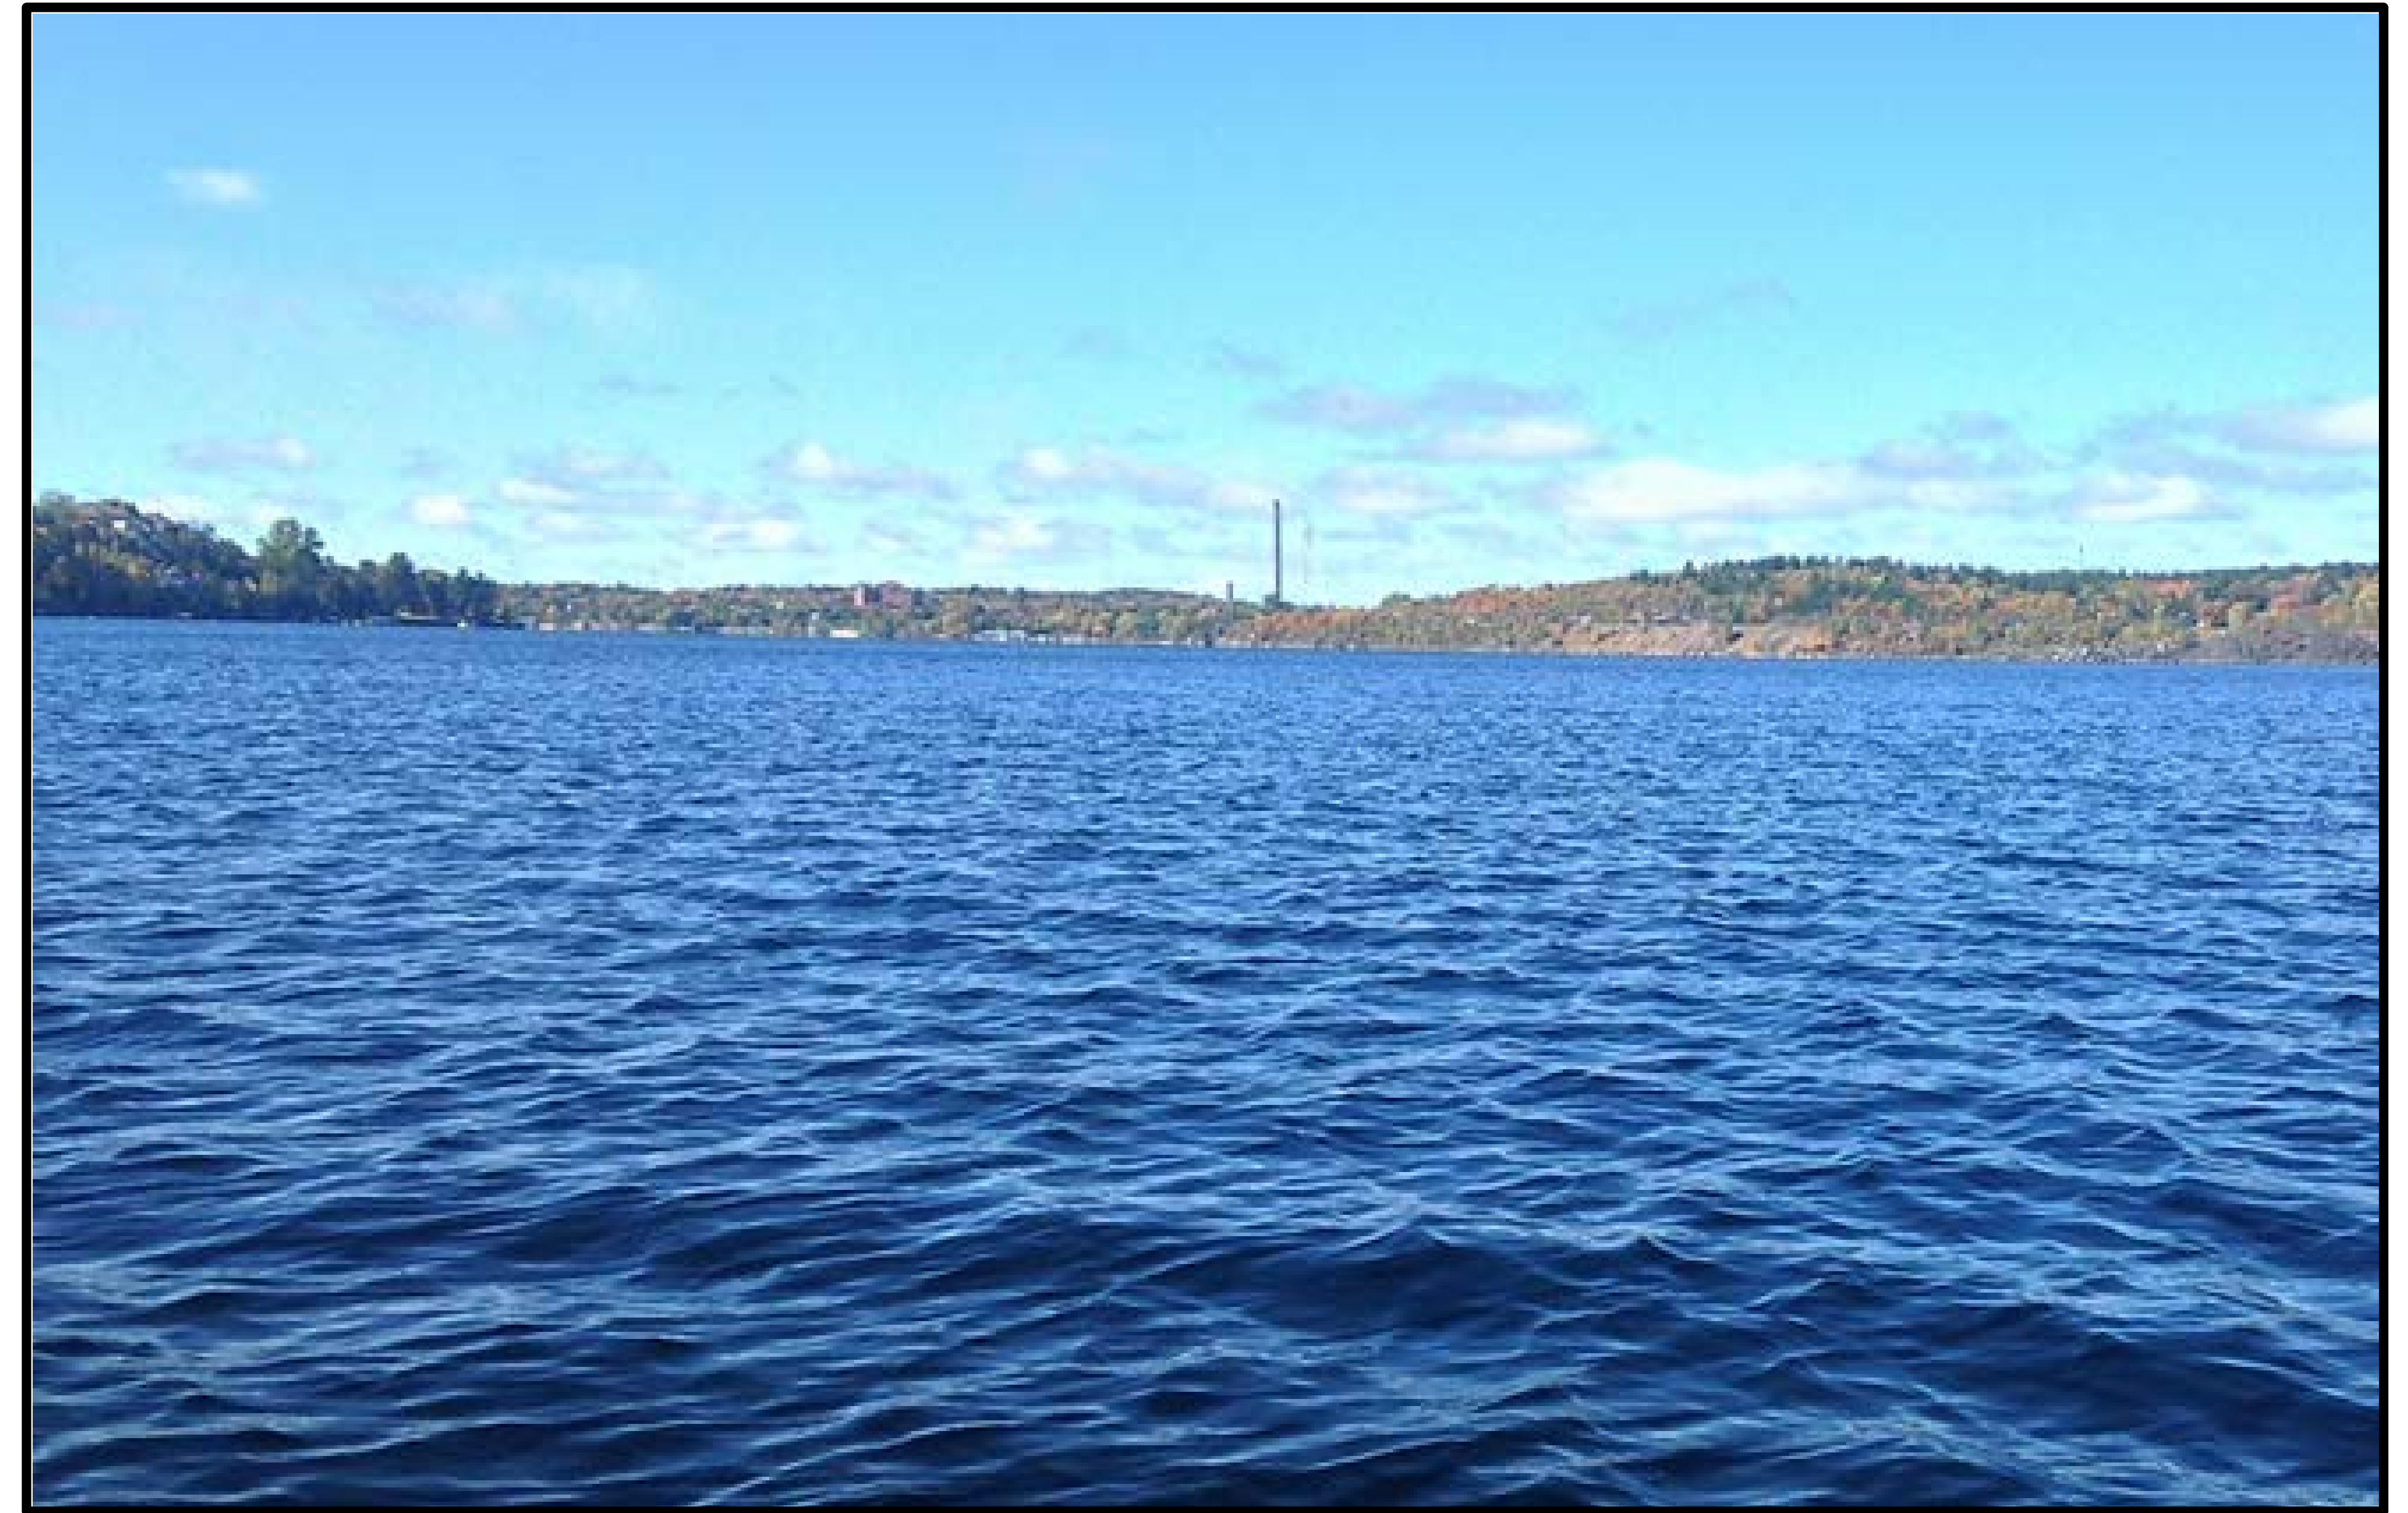
- **Metals concentrations in Ramsey Lake have been elevated from natural levels as a result of exposure to past emissions from local smelter operations**
- **Metals, including copper and nickel have decreased in response to a reduction in emissions of metal particulates from smelters**

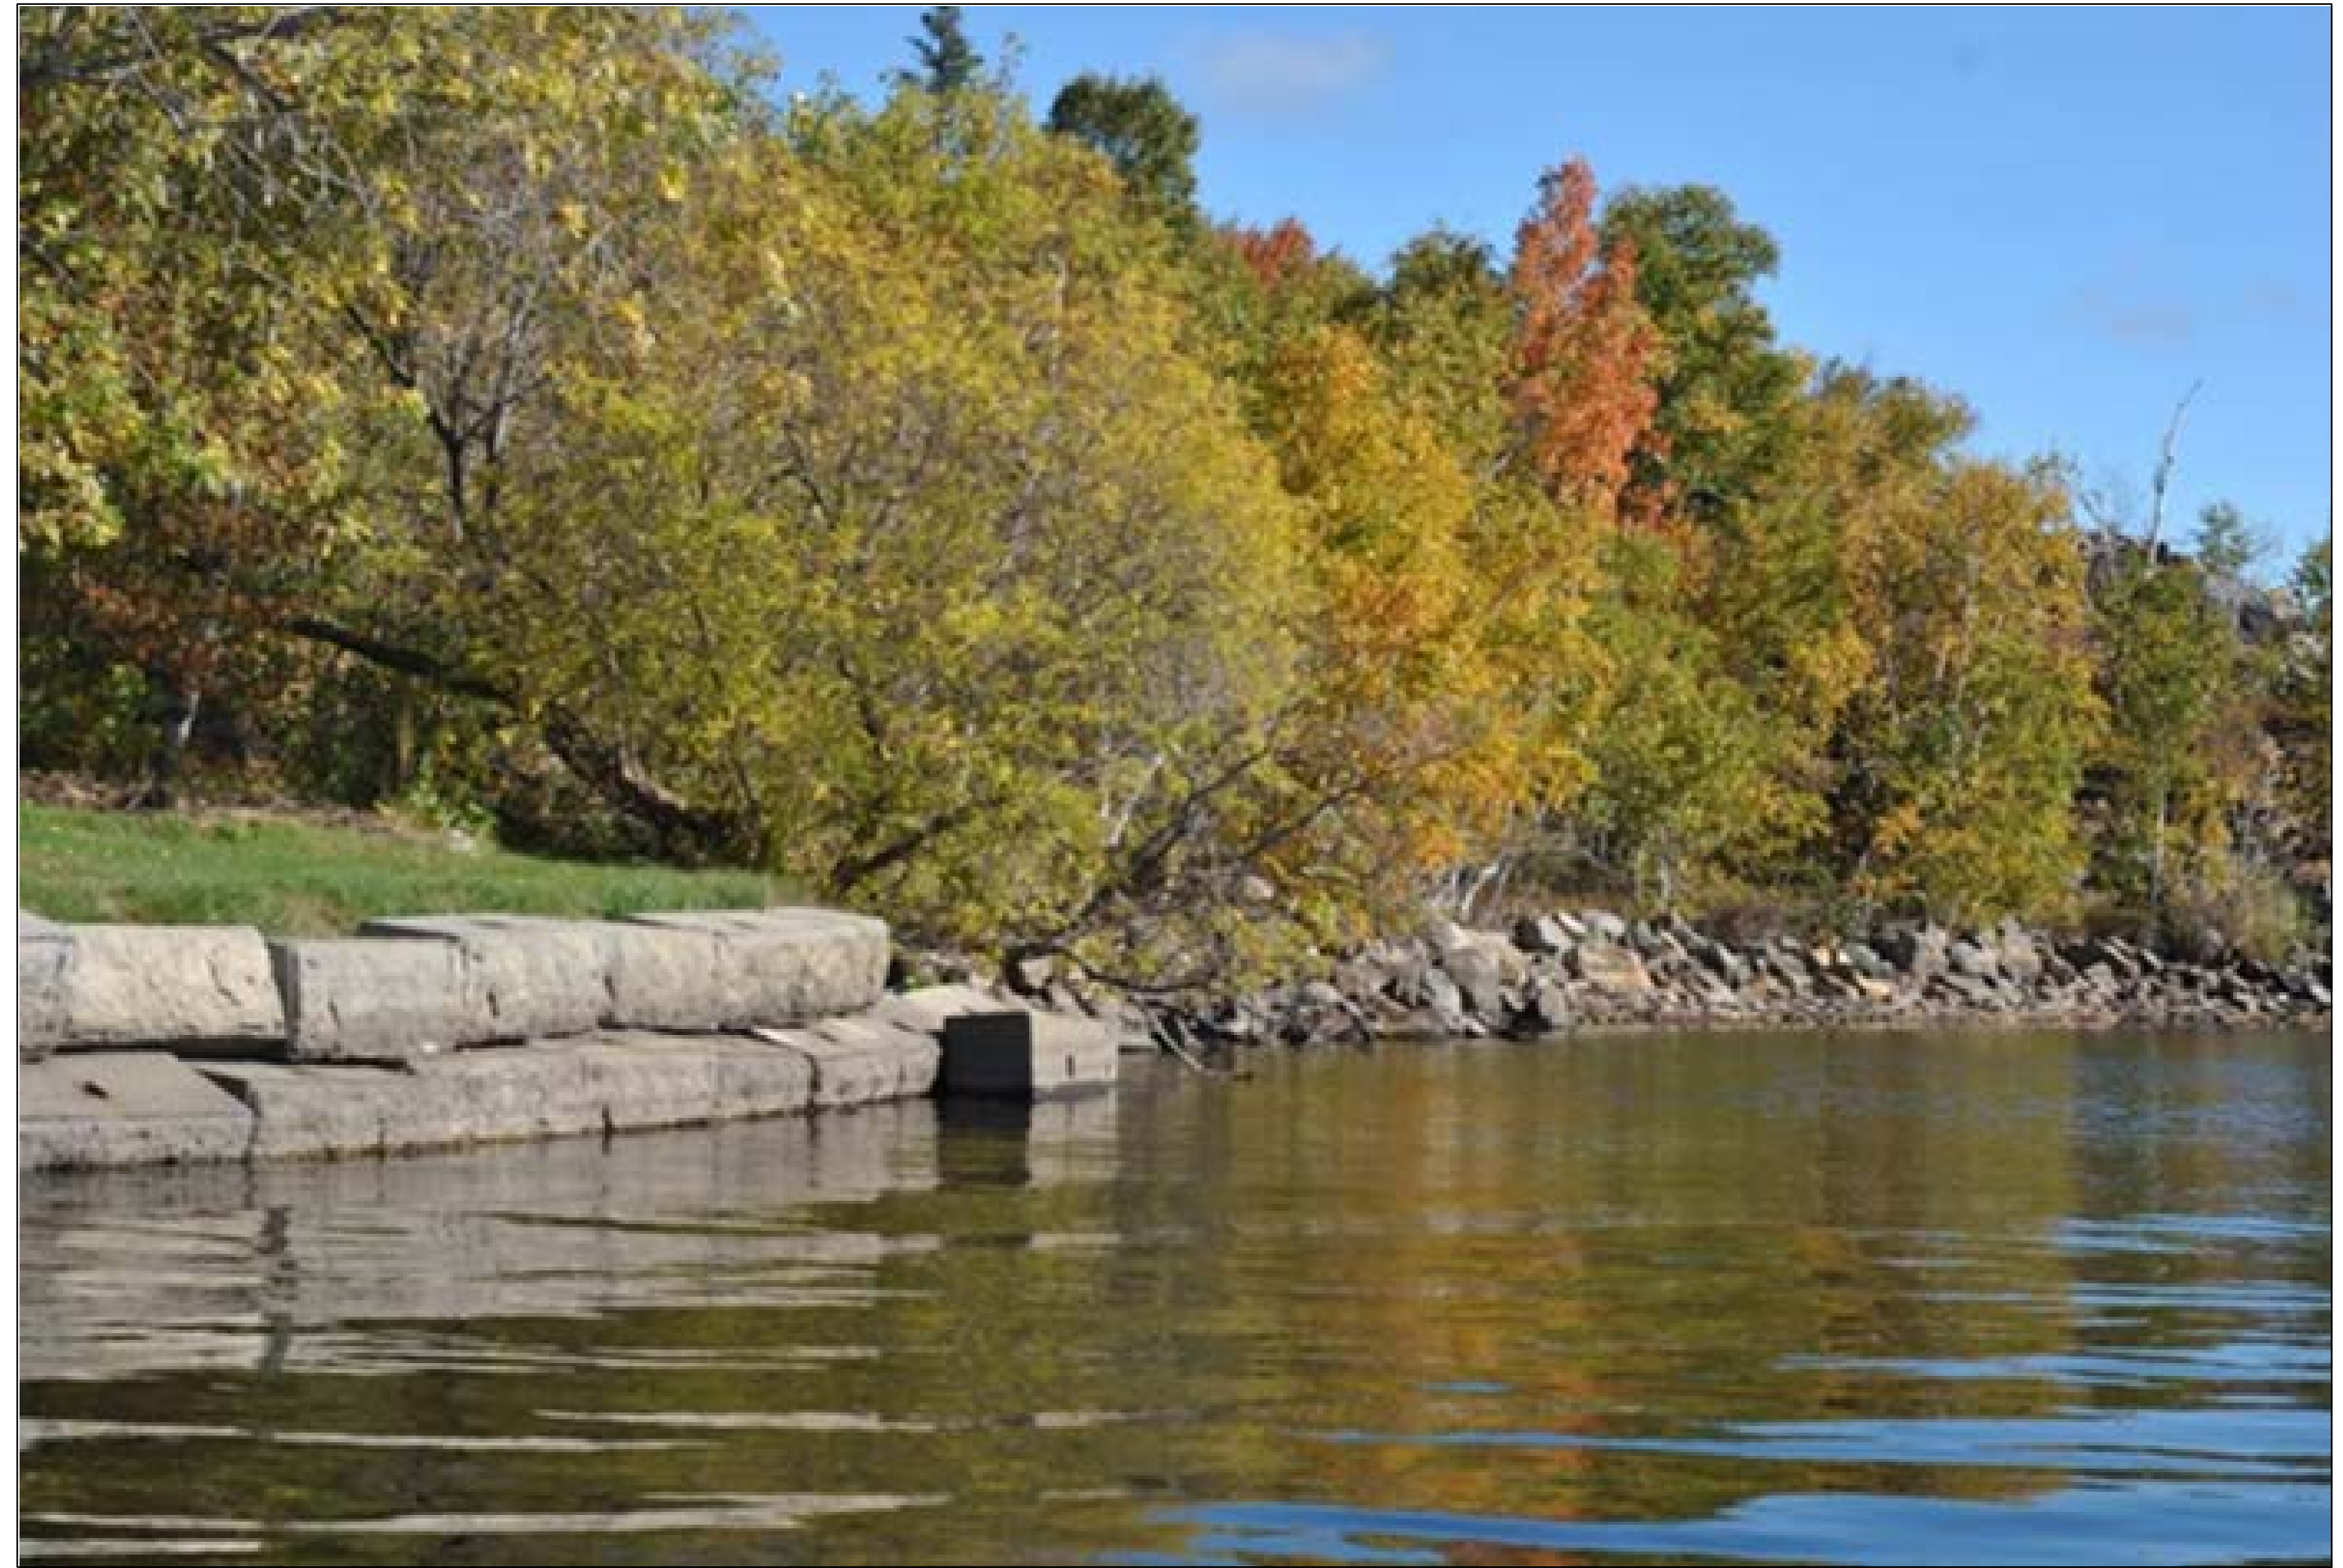
- **Development along the shoreline of the lake is extensive, including more than 800 private dwellings as well as public spaces.**
- **Much of the habitat provided by natural shoreline features has been altered.**
- **Aquatic vegetation growth is dense in shallow waters near heavily urbanized areas.**

**Altered and natural Shoreline; Ramsey Lake.**
