STRUCTURAL CONDITION EVALUATION OF

7 SERPENTINE STREET

COPPER CLIFF, ONTARIO

MAY 5, 2016

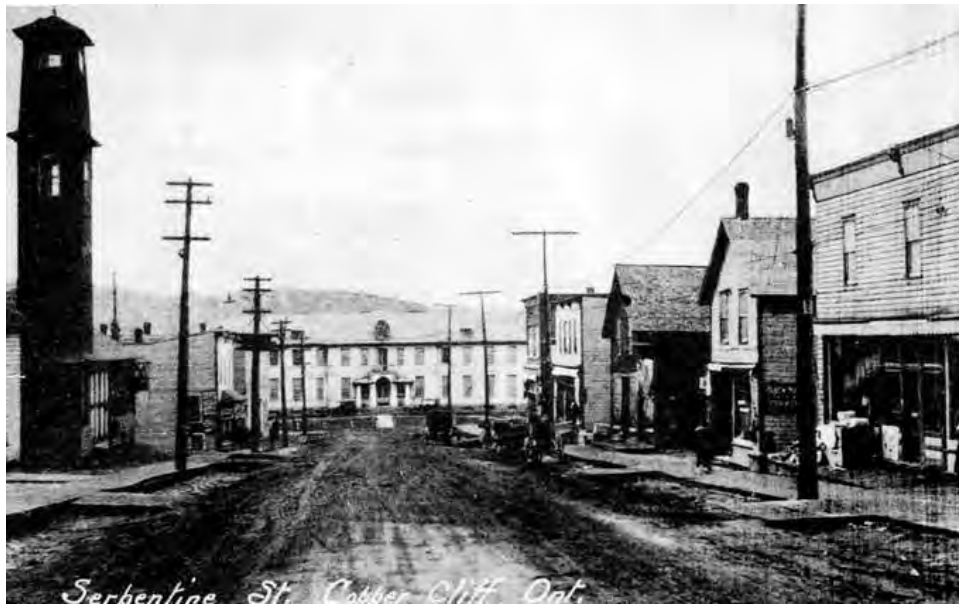
Figure 1: Copper Cliff Fire Hall circa 1913. Original lookout tower is visible at far left.

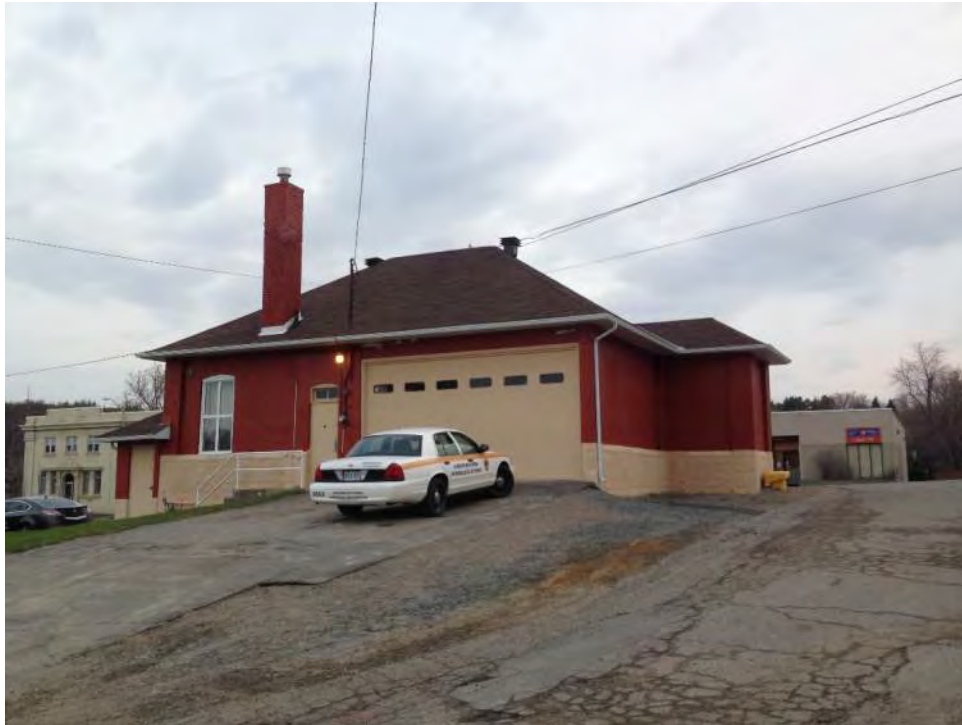
Figure 3: General view of southeast elevation.

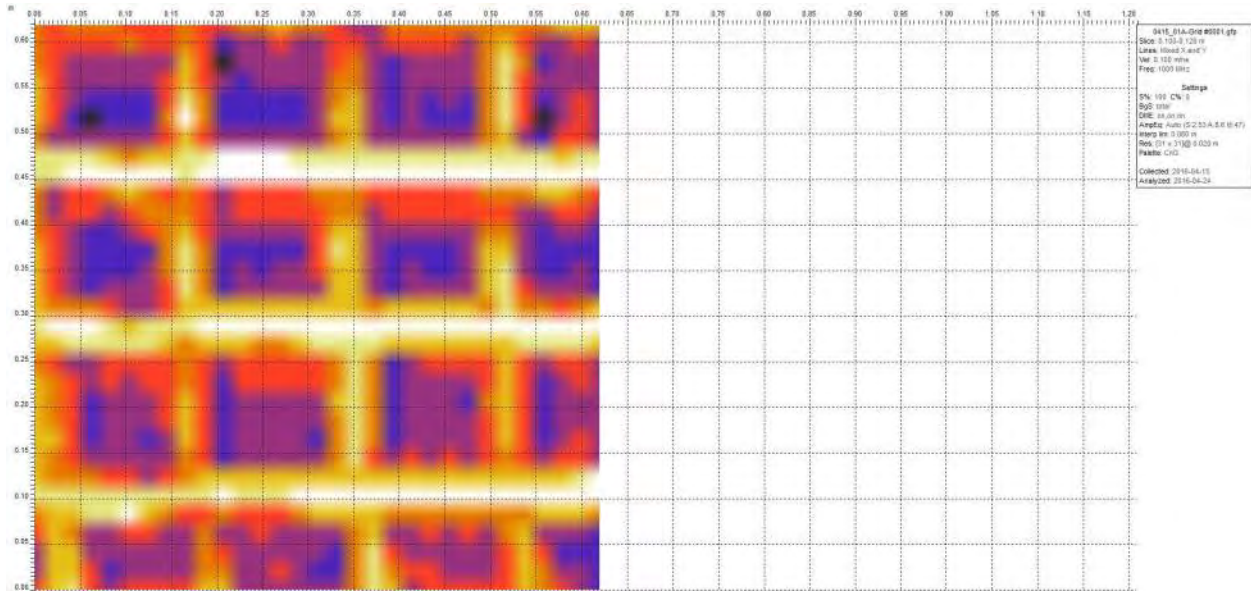
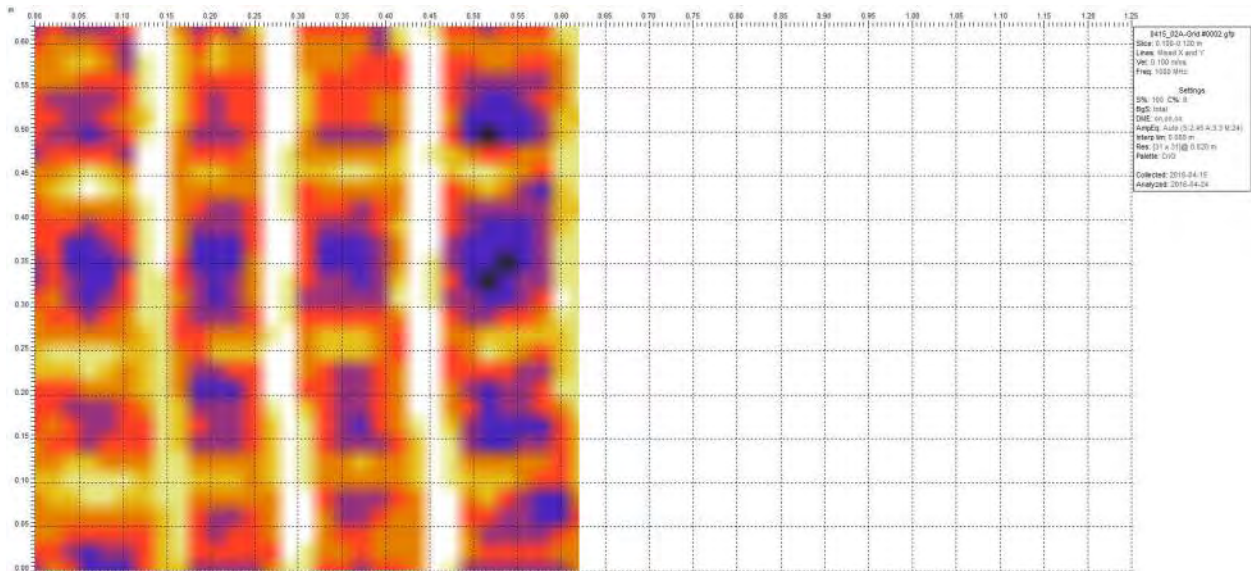
The inspection confirmed the existence of one layer of small diameter rebar or wire mesh, as well as slab thickness of 150mm.
