'AMENDED' - SELLING INFORMATION -
(THIS IS NOT A TENDER)

- Municipal Address: **7 Serpentine Street, Copper Cliff, ON**
On which is situate the building commonly referred to as the former Copper Cliff Fire Hall
- Legal Description: PIN 73599-0173(LT), Surface Rights Only, formerly Parcel 40945, SES, Lot 79, Plan M-1025, Township of McKim, City of Greater Sudbury
- Approximate Size of Site: 602 square meters (6,480 square feet)
- Official Plan & Zoning: The lands are designated “Mixed Use Commercial” in the Official Plan and are zoned “C2”- General Commercial, in Zoning By-law 2010-100Z.

STRUCTURAL CONDITION EVALUATION OF

MAY 5, 2016

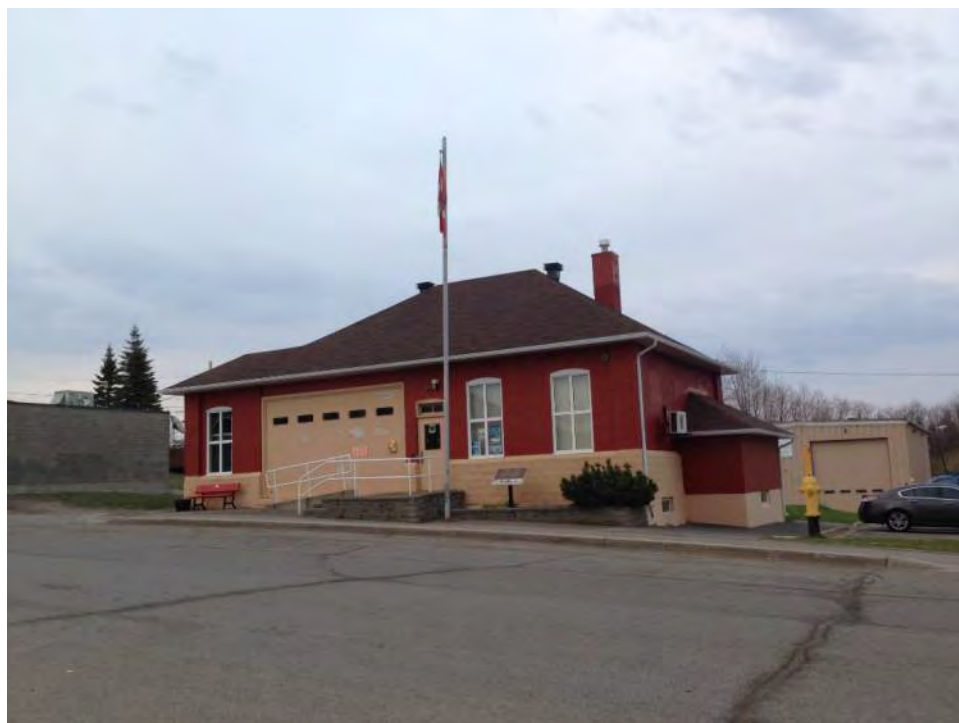
Figure 2: General view of northwest elevation.

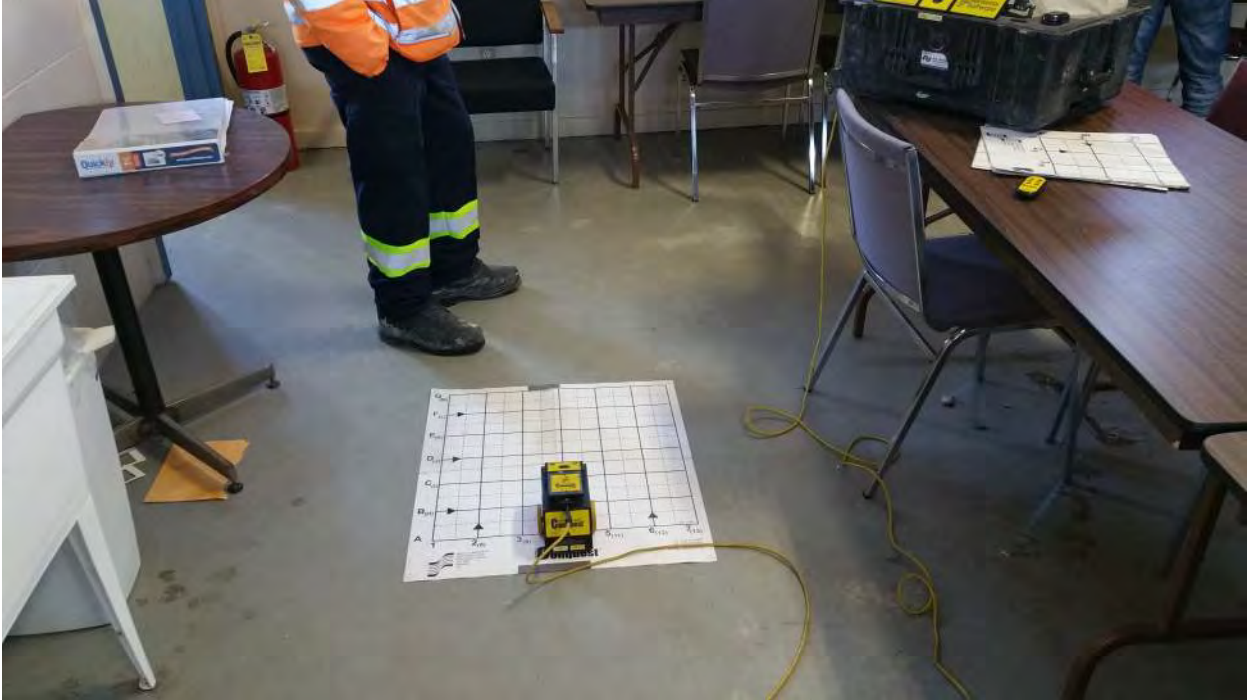
Grid Scan 1 Location

The inspection confirmed the existence of one layer of small diameter rebar or wire mesh, as well as slab thickness of 150mm.

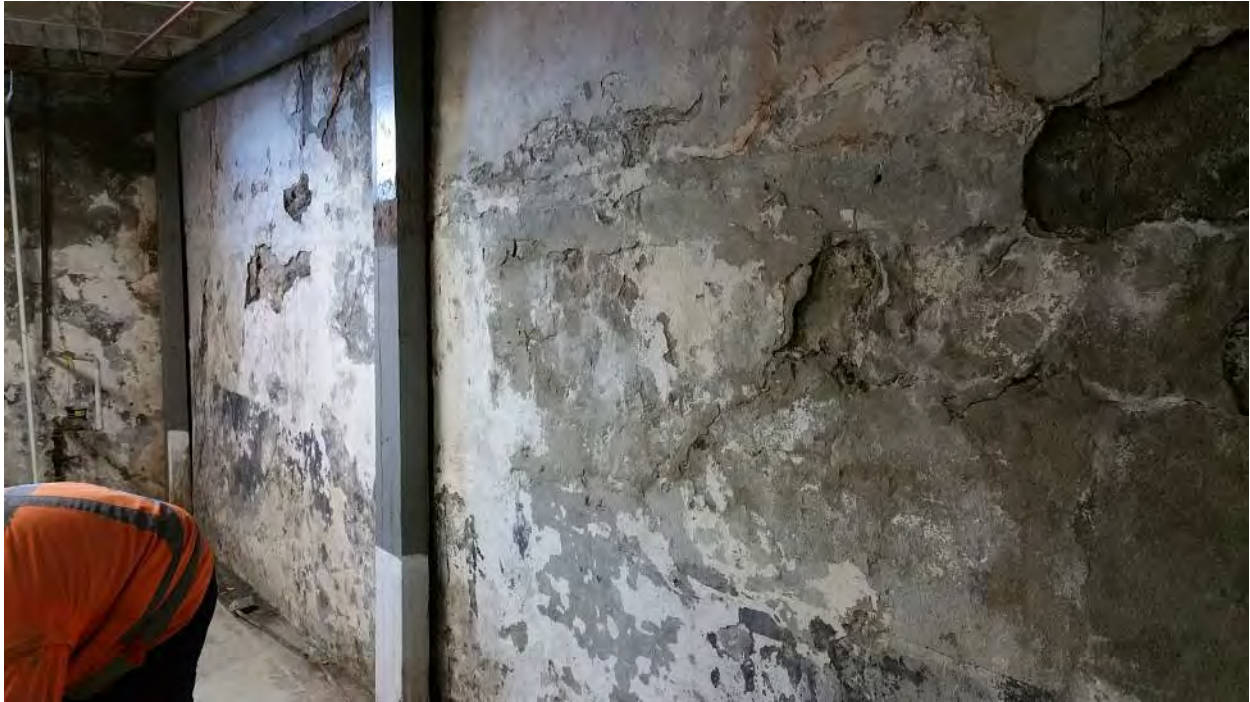
Location of Line Scan 6 & 7

Additionally, scans of the basement walls were conducted to confirm the existence of structural reinforcement. These scans did not identify any reinforcement in the concrete.

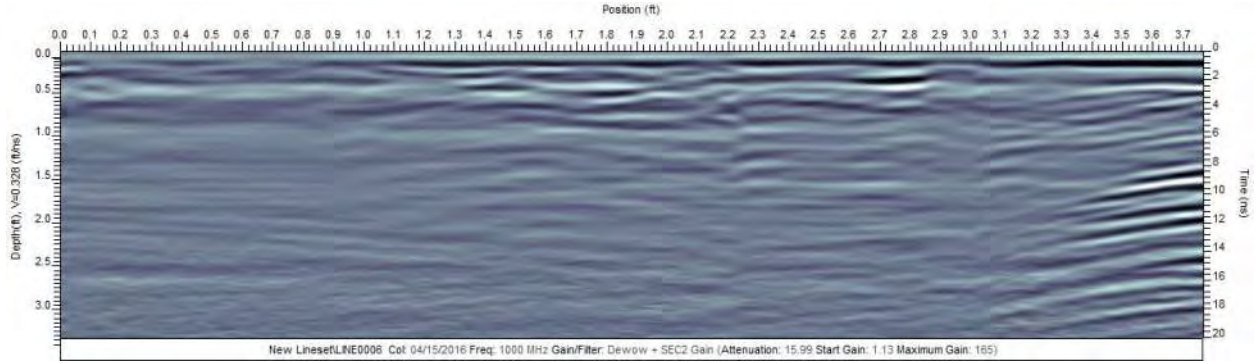
Line Scan 6 Vertical Image

In conclusion a single layer of small diameter rebar or wire mesh is present in the former garage floor, however reinforcement is not present in the basement foundation walls.
